**JOINT FEDERAL/STATE APPLICATION
FOR THE ALTERATION OF ANY
FLOODPLAIN, WATERWAY, TIDAL OR
NONTIDAL WETLAND IN MARYLAND**

APPLICATION AMENDMENT 1

**BEL AIR IMPOUNDMENT AND
WINTERS RUN INTAKE PROJECT**

Town of Bel Air
Harford County, Maryland

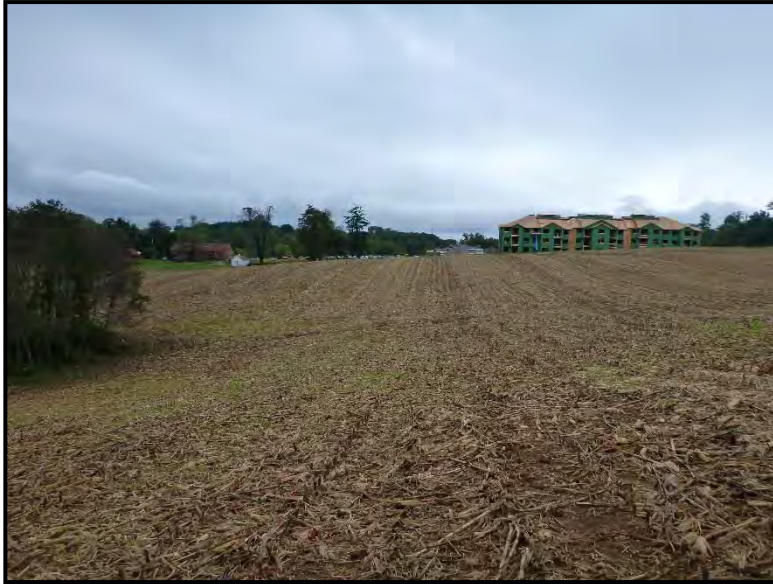
Photo 1 (09-29-2015)
View of the agricultural field looking southwest from the approximate reservoir location. New residential construction and the barn are visible in the distance.

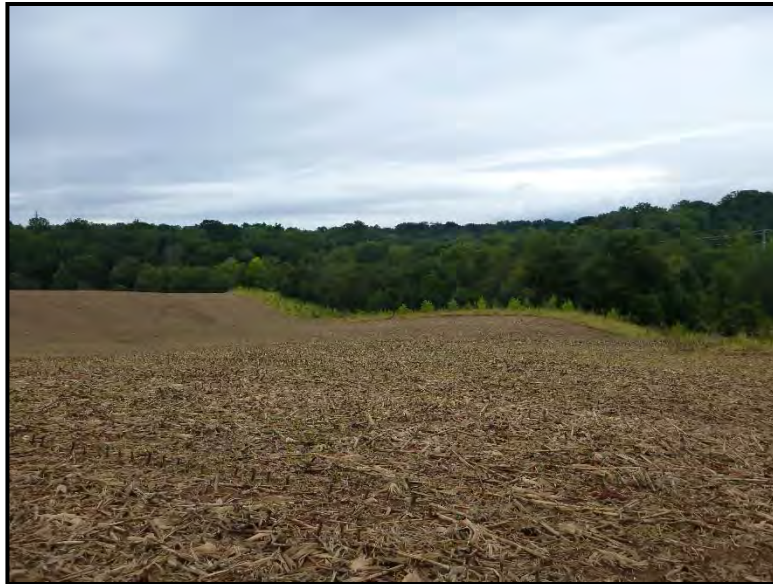
Photo 2 (09-29-2015)
View of the agricultural field and reforestation planting area looking east.

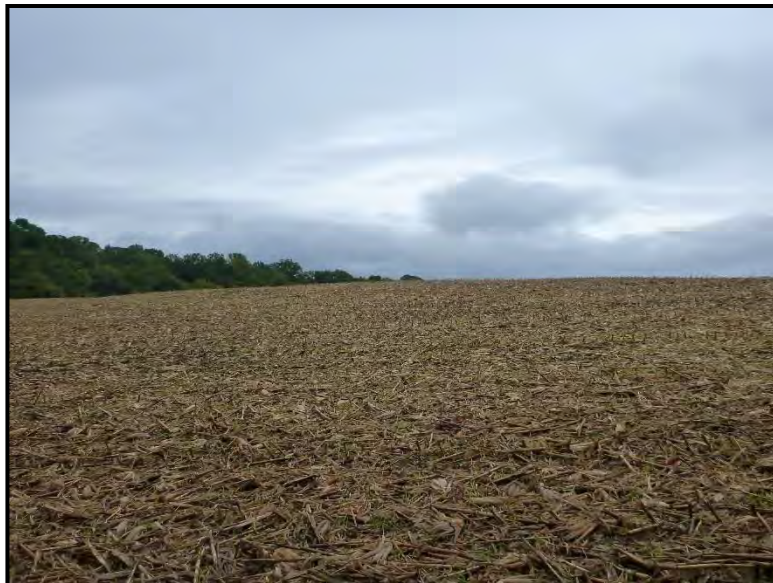
Photo 3 (09-29-2015)
View of the agricultural field and approximate reservoir location looking south from the floodplain forest tree line.

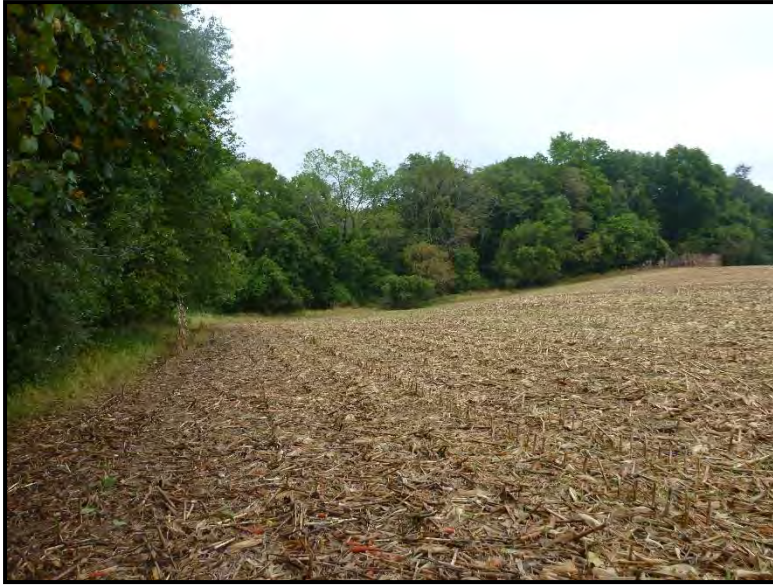
Photo 4 (09-29-2015)
View of the agricultural field and floodplain forest tree line looking east from the northwestern most corner of the agricultural field.

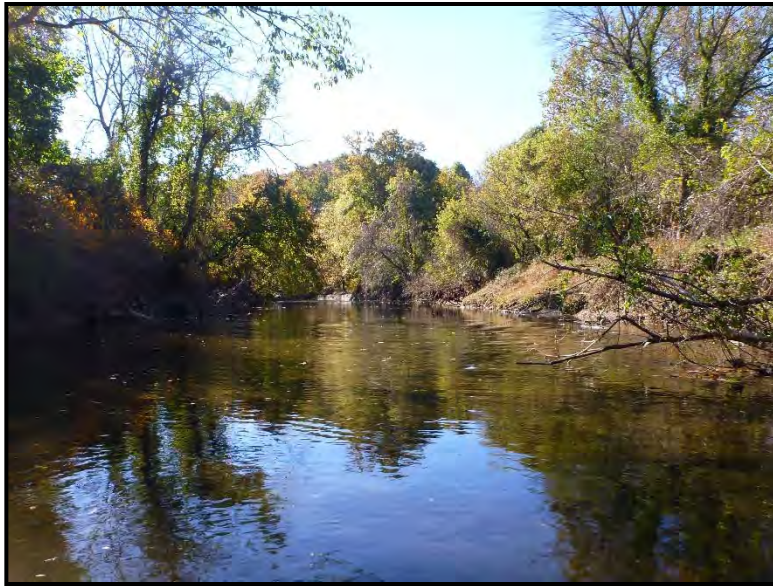
Photo 5 (10-19-2015)
View of Winters Run looking downstream from near the proposed floodplain and stream crossing. View is south.

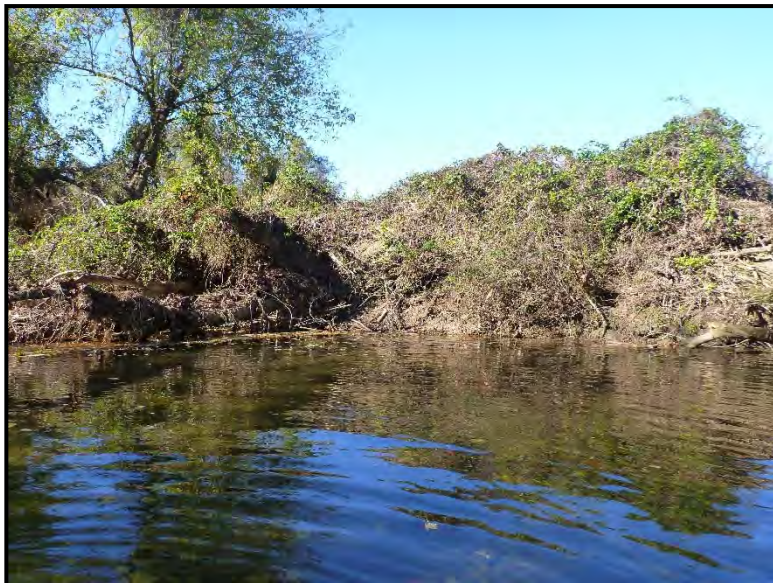
Photo 6 (10-19-2015)
View of the downstream right bank of Winters Run at the approximate location of the proposed outfall structure and water pipeline crossing. View is west.

The group reviewed the proposed crossing of Winters Run where the impoundment would be connected to the water treatment plant. D. Graff pointed out the wooden stakes marked with pink flagging that identified the proposed limits of the work area in reference to project drawings. Directional drill and bore pits were discussed and that open trench was not currently considered. The agencies raised a concern of an inadvertent return of slurry as part of the boring efforts and that an in-stream restriction of March 1 thru May 31 would be expected as a permit condition along with a plan to address any inadvertent returns that could escape into Winters Run. A frack-out contingency plan would also have to be submitted and accepted before the permit will be issued.

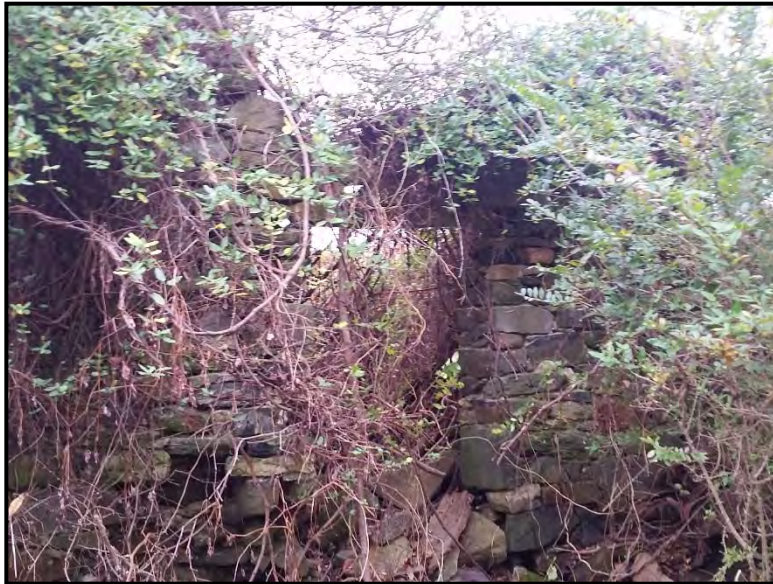
Photo 8 (11-02-2015)
View of springhouse located downslope of the reforestation planting area and the wetland complex.

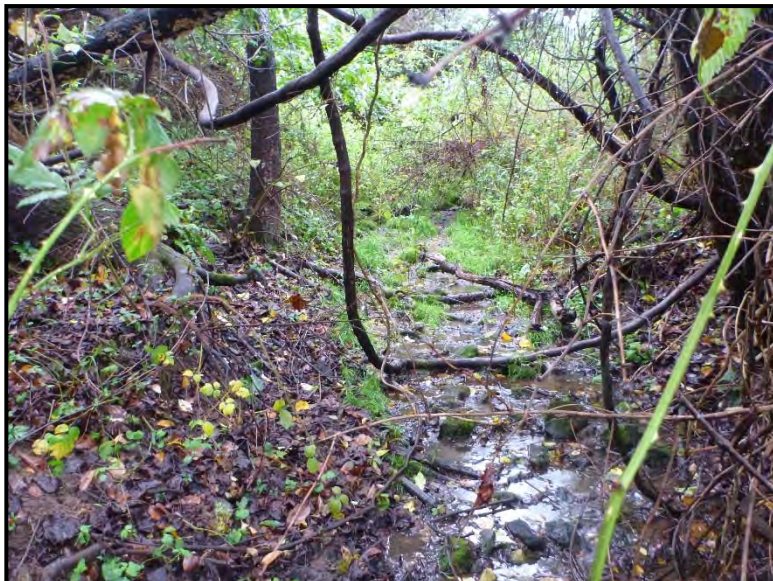
Photo 9 (09-30-2015)
Downstream view from the spring house. The watercourse drains into a palustrine emergent (PEM) wetland complex, then to an unnamed tributary to Winters Run. View is east.

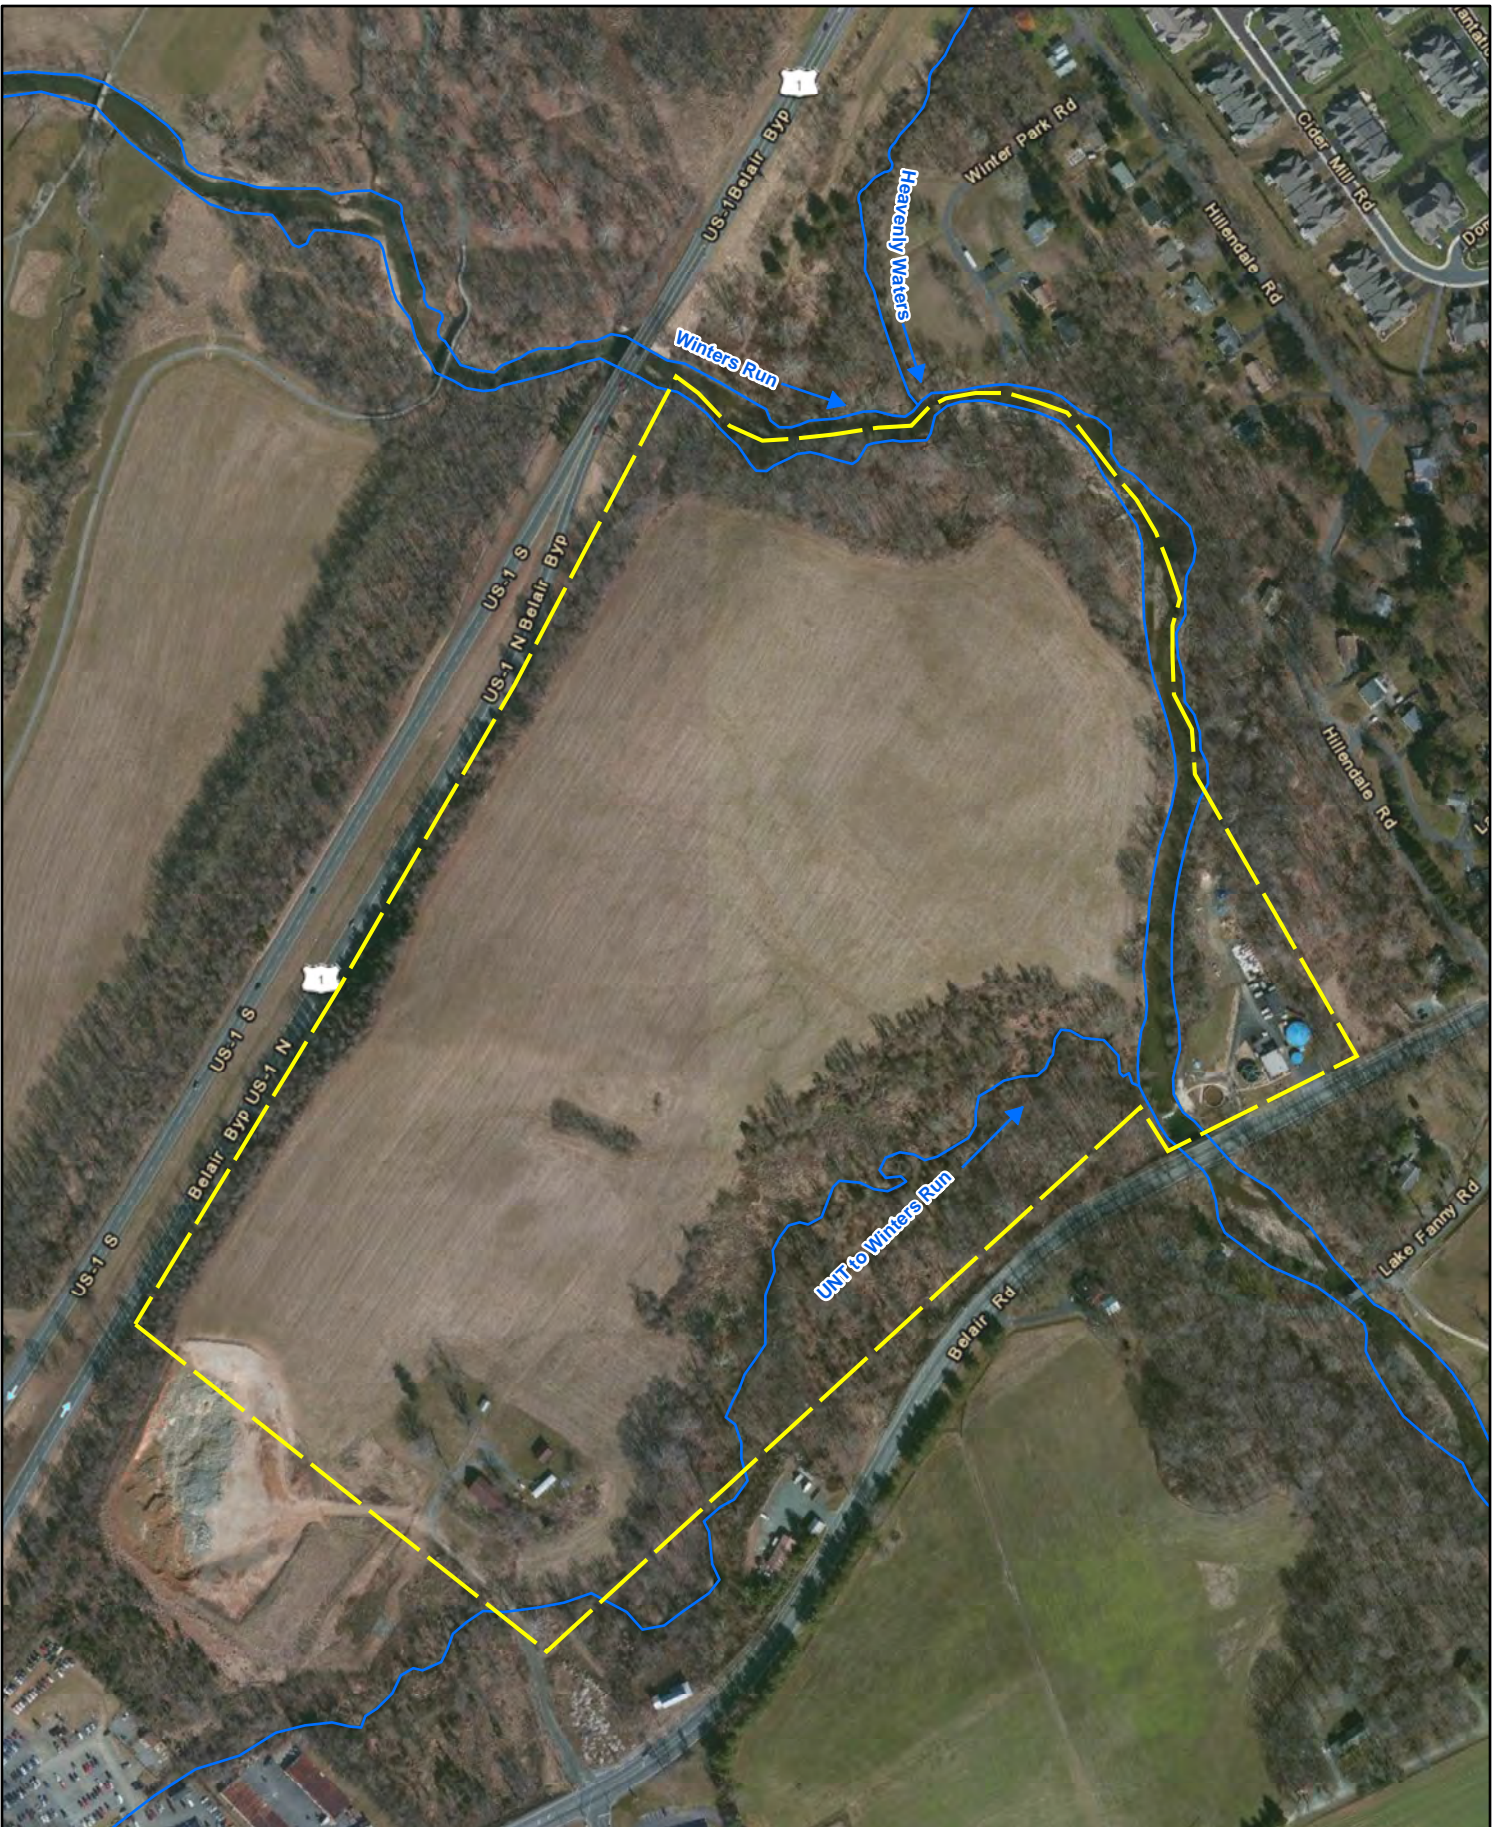
**Figure 3
Soil Survey Map**

According to the U.S. Department of Agriculture (USDA), Natural Resources Conservation Service (NRCS) Soil Survey for Harford County, the soil series within the project study area includes the following listed below in Table 1. An excerpt from the soil survey is provided below as **Figure 3**.

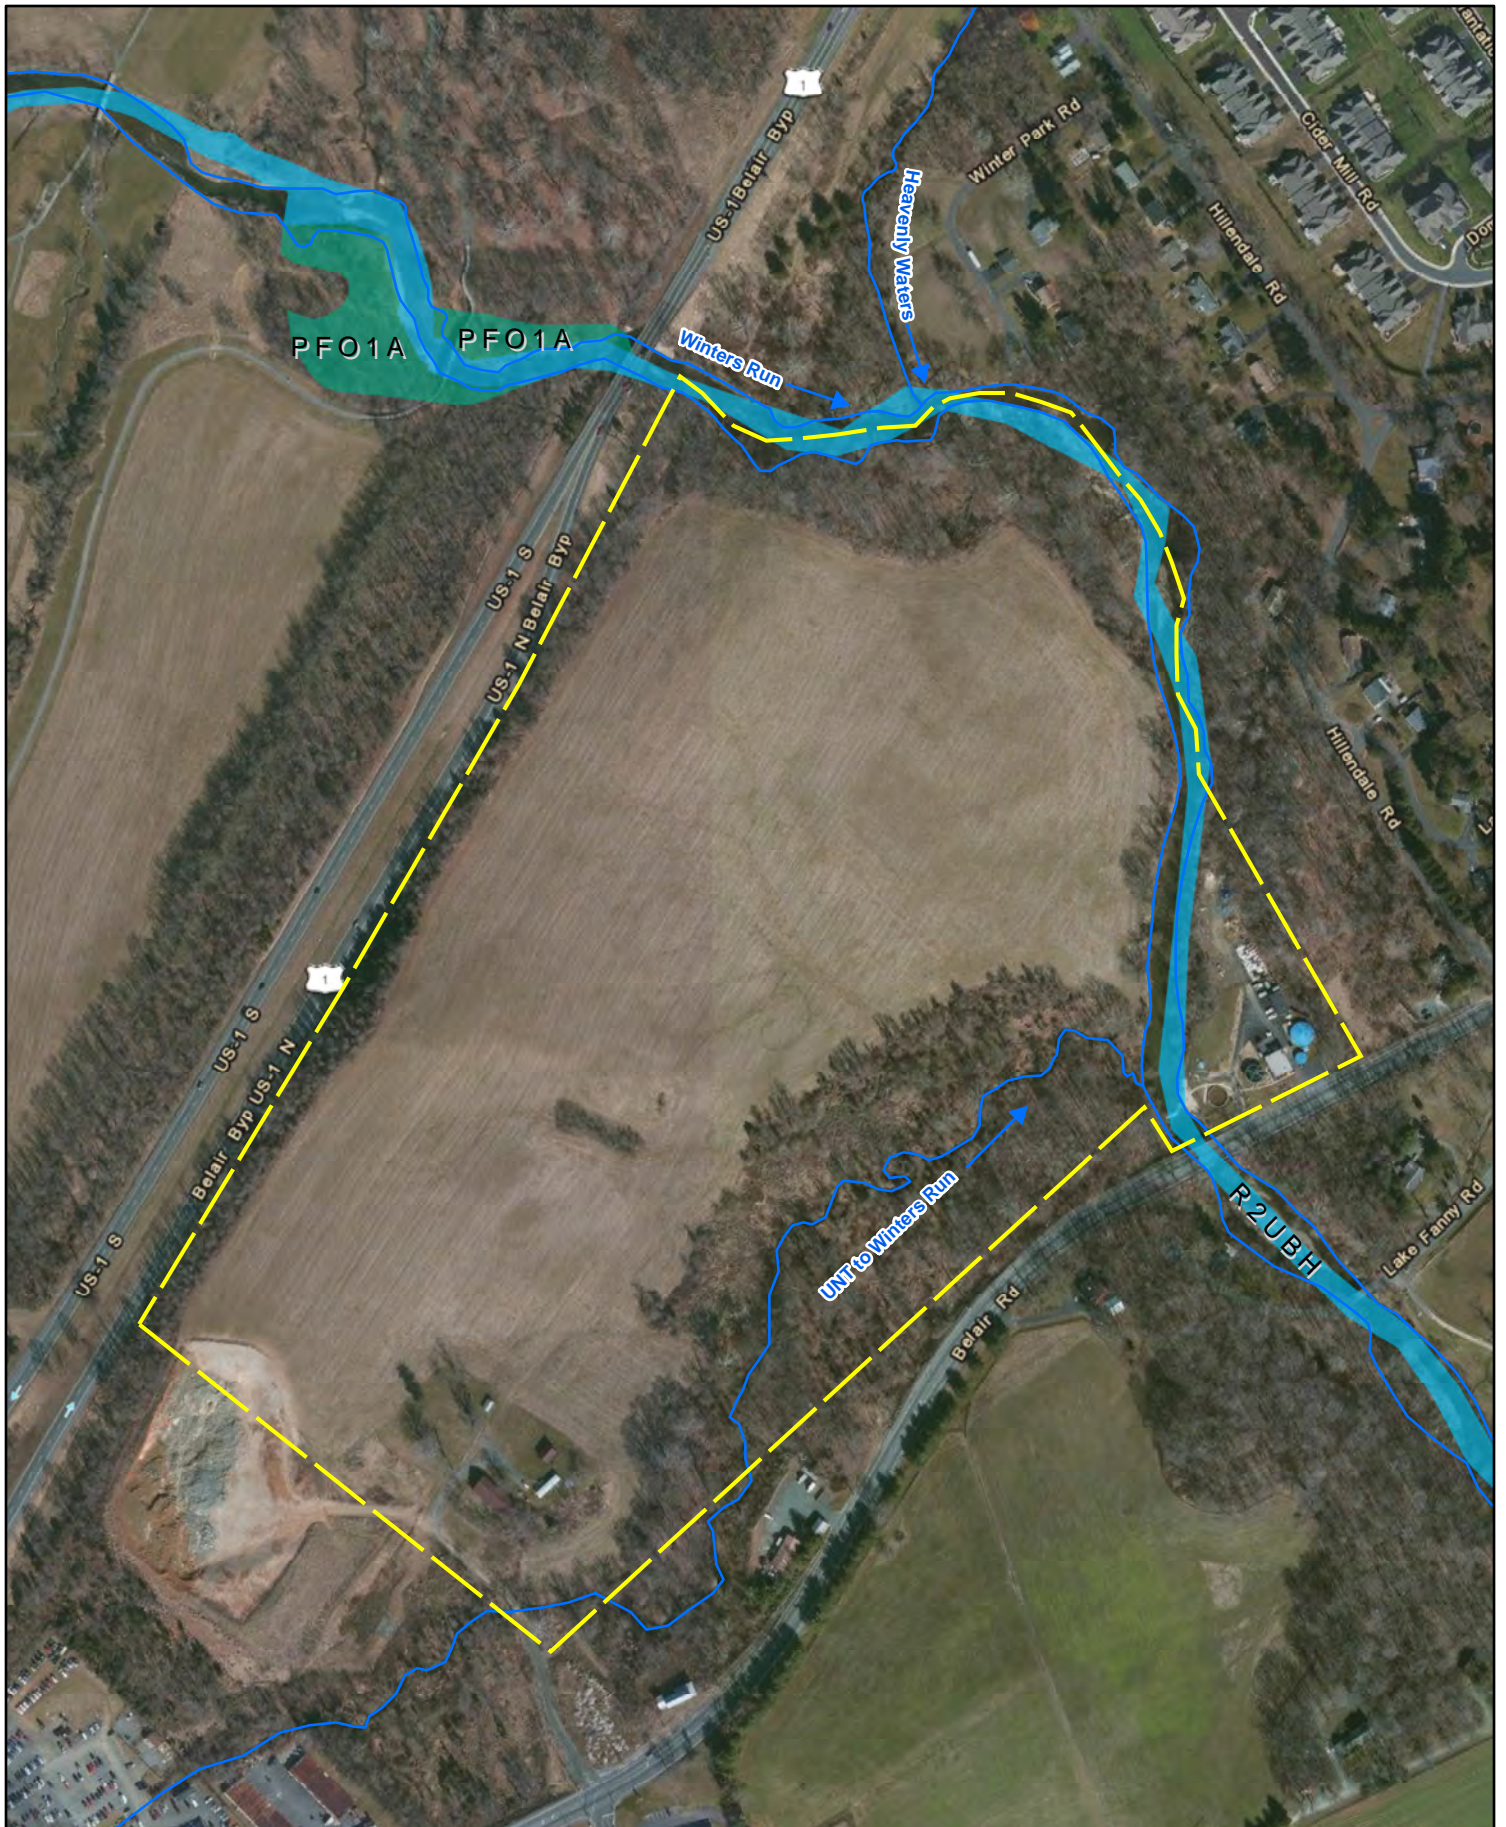
Figure 4
National Wetlands Inventory Map
Bel Air Impoundment Project
MARYLAND AMERICAN WATER
Town of Bel Air, Harford County, Maryland

The National Wetlands Inventory (NWI) online mapping tool identified Winters Run as a riverine, lower perennial, unconsolidated bottom, permanently flooded (R2UBH) feature. No other NWI features were mapped the project study area. The NWI map for the site is provided as **Figure 4**.

- Project Study Area
- Streams
- NWI Wetlands**
- Freshwater Forested/Shrub Wetland
- Riverine

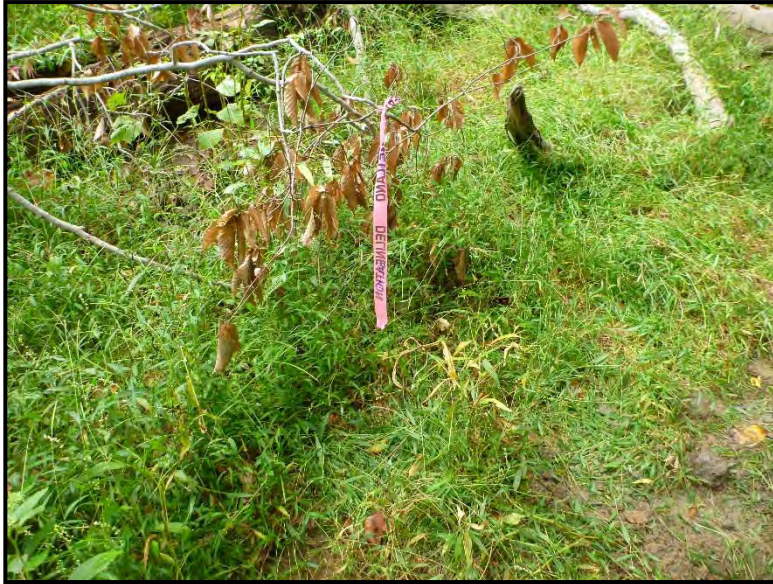
Photo 1 (09-29-2015)
Wetland 1 (W1) is a palustrine emergent (PEM) wetland located on the eastern bank floodplain of Winters Run. View is close-up of wetland plot.

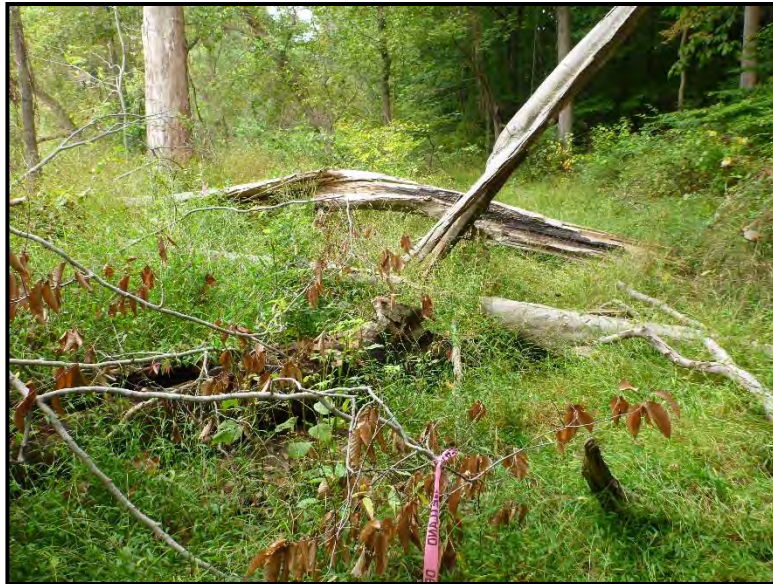
Photo 2 (09-29-2015)
Wetland 1 (W1) extends off the project study area for a short distance before connecting to Winters Run. View is northwest from wetland plot.

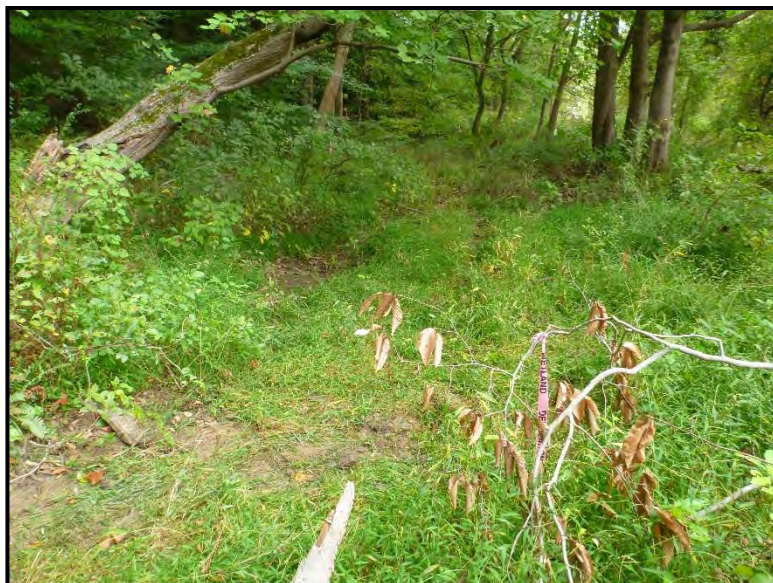
Photo 3 (09-29-2015)
Wetland 1 is a toe-of-slope drainage swale that is partially an unvegetated, concave surface. View is southeast from wetland plot.

Photo 3 (09-29-2015)
Wetland 1 is a toe-of-slope drainage swale that is partially an unvegetated, concave surface. View is southeast from wetland plot.

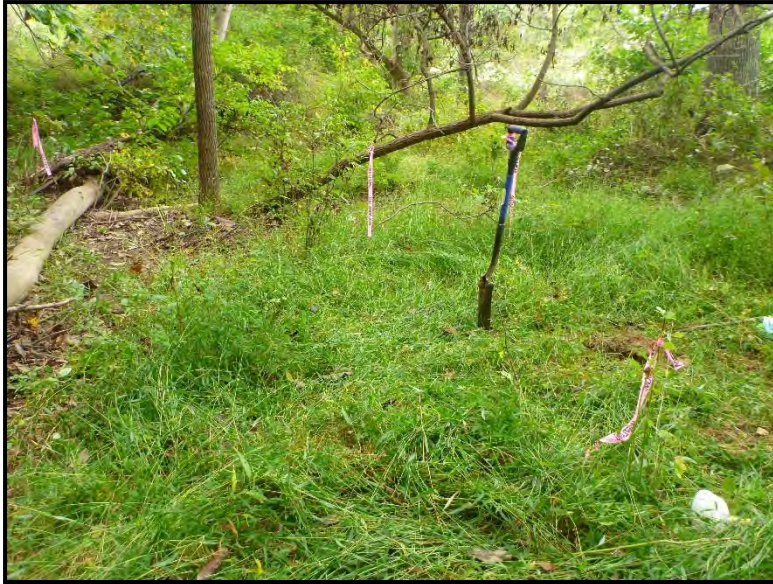
Photo 4 (09-29-2015)
Upland plot for the project study area is on the floodplain of Winters Run. View is southwest near Wetland 1 boundary and start of Stream 1.

Photo 4 (09-29-2015)
Upland plot for the project study area is on the floodplain of Winters Run. View is southwest near Wetland 1 boundary and start of Stream 1.

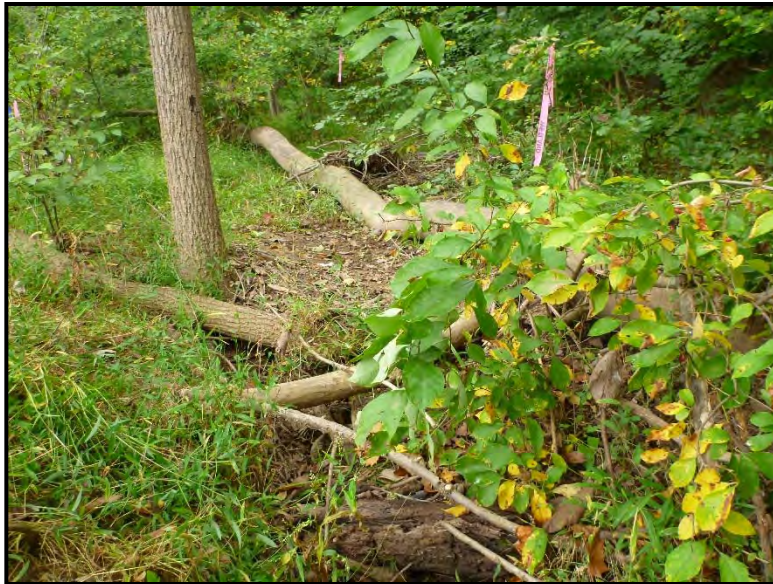
Photo 5 (09-29-2015)
Stream 1 (S1) is an ephemeral watercourse located between Wetland 1 and Winters Run. View is north and upstream from Flag S1-1.

Photo 5 (09-29-2015)
Stream 1 (S1) is an ephemeral watercourse located between Wetland 1 and Winters Run. View is north and upstream from Flag S1-1.

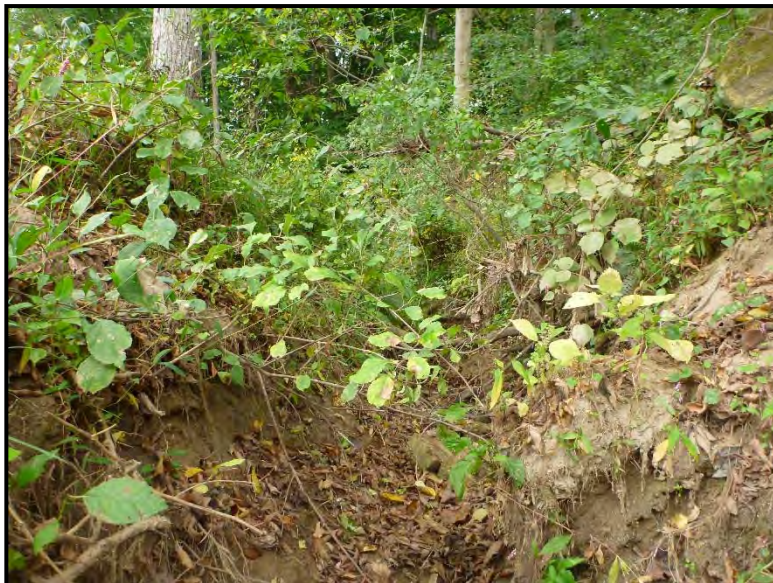
Photo 6 (09-29-2015)
Upstream view of Stream 1 from flag S1-4 looking northeast.

Photo 6 (09-29-2015)
Upstream view of Stream 1 from flag S1-4 looking northeast.

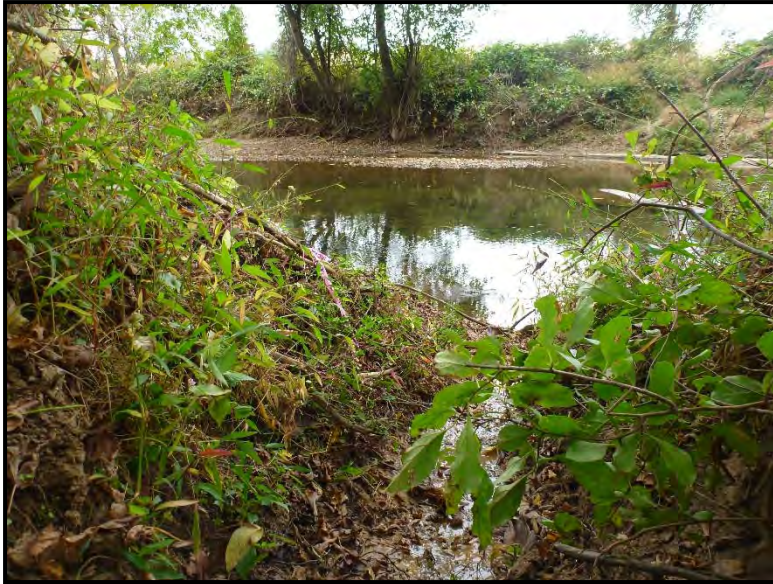
Photo 7 (09-29-2015)
Downstream view of Stream 1 at flag S1-4 looking south at junction with Winters Run.

Photo 7 (09-29-2015)
Downstream view of Stream 1 at flag S1-4 looking south at junction with Winters Run.

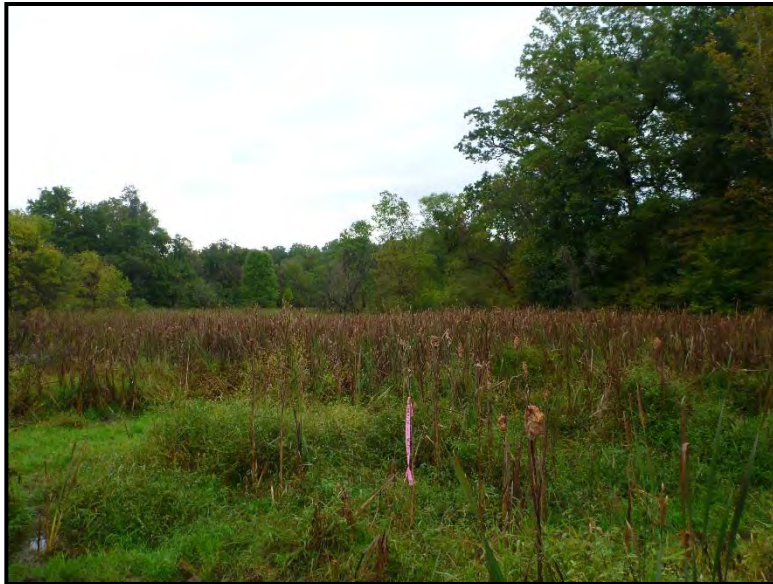
Photo 8 (09-30-2015)
Wetland 2 (W2) is a PEM wetland dominated by tearthumb, reed canary grass, and cattail. View is northeast at the wetland plot.

Photo 8 (09-30-2015)
Wetland 2 (W2) is a PEM wetland dominated by tearthumb, reed canary grass, and cattail. View is northeast at the wetland plot.

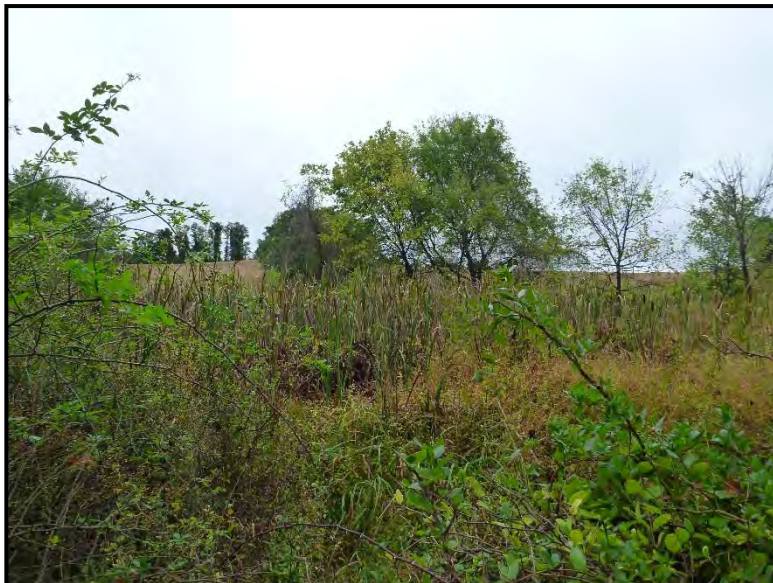
Photo 9 (09-30-2015)
Wetland 2 overview from flag W2-11 and left bank of UNT to Winters Run (S8). View is looking west.

Photo 9 (09-30-2015)
Wetland 2 overview from flag W2-11 and left bank of UNT to Winters Run (S8). View is looking west.

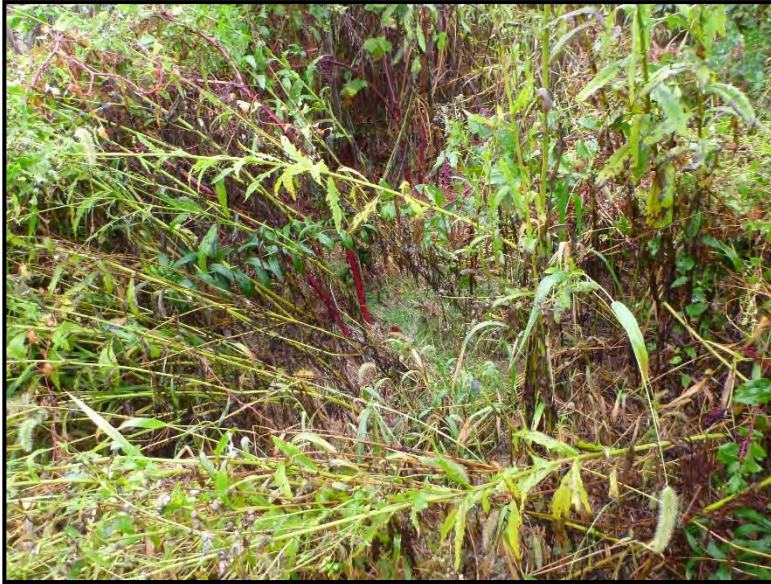
Photo 10 (09-30-2015)
Upstream view of Stream 2,
ephemeral stream originating at
spring. View is west from flag S2-1.

Photo 10 (09-30-2015)
Upstream view of Stream 2,
ephemeral stream originating at
spring. View is west from flag S2-1.

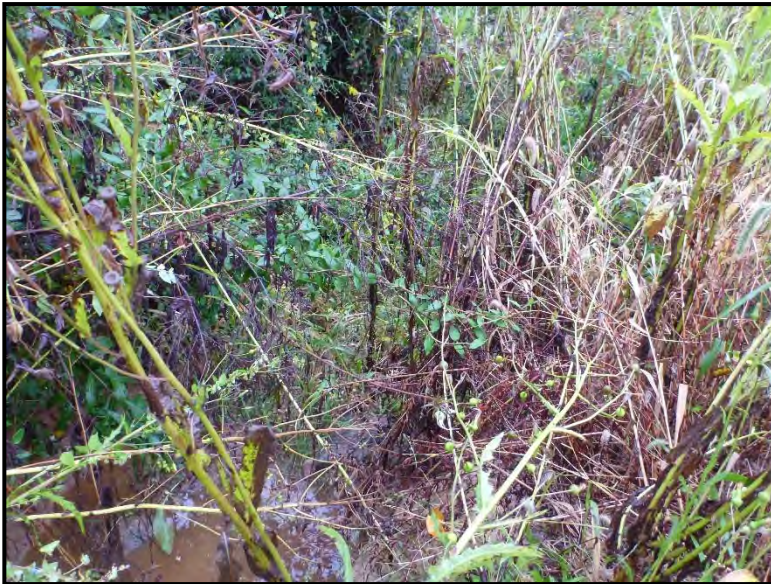
Photo 11 (09-30-2015)
Downstream view of Stream 2. View
is east from flag S2-1.

Photo 11 (09-30-2015)
Downstream view of Stream 2. View
is east from flag S2-1.

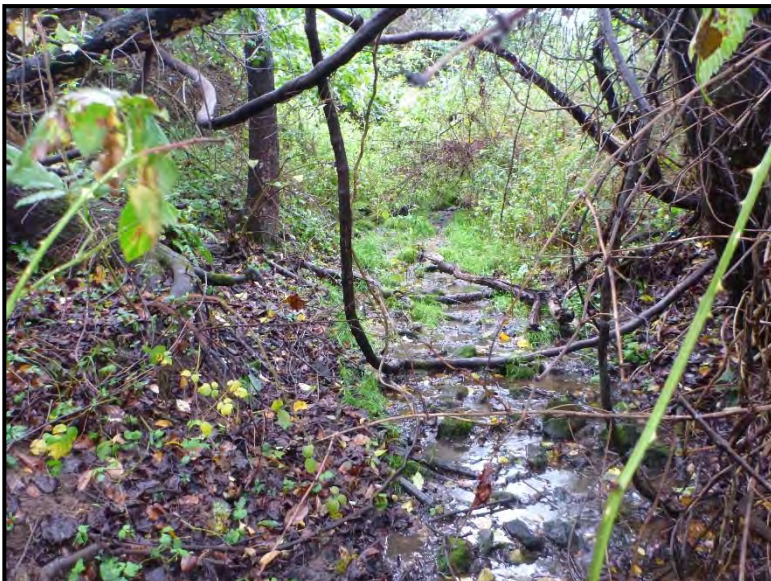
Photo 12 (09-30-2015)
Upstream view of Stream 3,
perennial stream originating at
springhouse. View is east from flag
S3-4.

Photo 12 (09-30-2015)
Upstream view of Stream 3,
perennial stream originating at
springhouse. View is east from flag
S3-4.

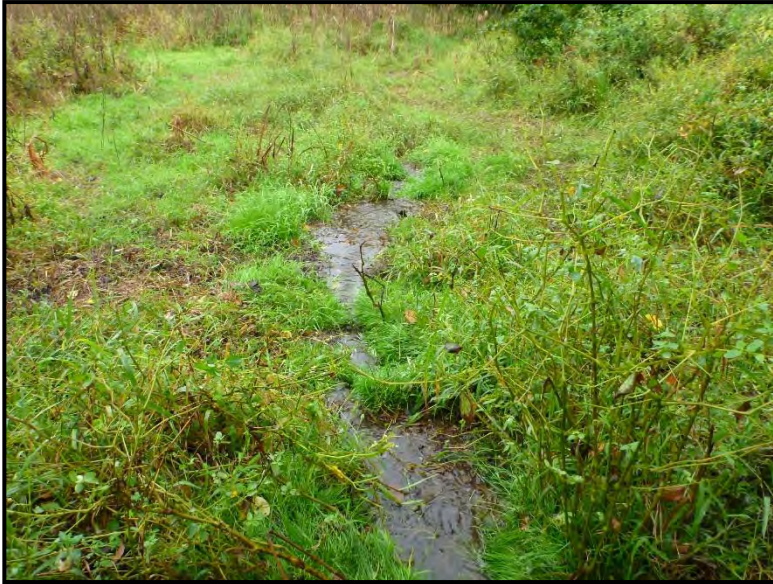
Photo 13 (09-30-2015)
Downstream view of Stream 3
before diffusing into Wetland 2.
View is east from flag S3-4.

Photo 13 (09-30-2015)
Downstream view of Stream 3
before diffusing into Wetland 2.
View is east from flag S3-4.

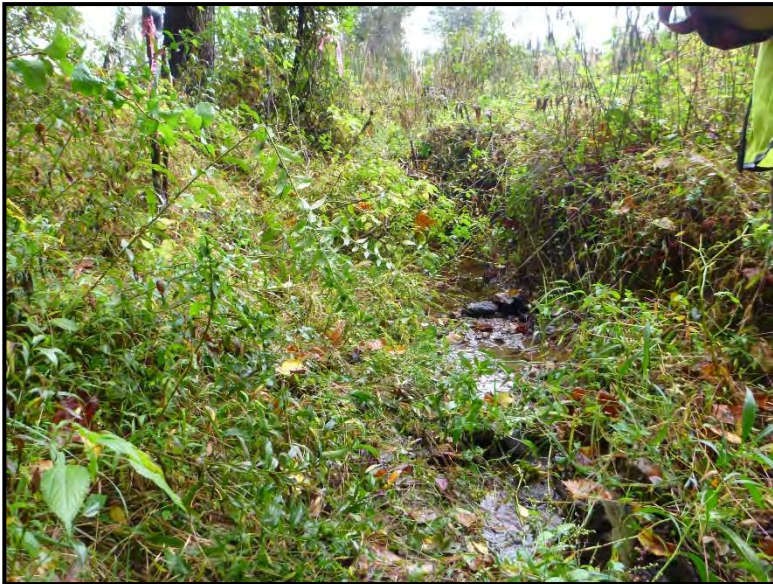
Photo 14 (09-30-2015)
Upstream view of Stream 3 when
rechannelizes at UNT to Winters
Run (S8). View is west from flag S3-
6B.

Photo 14 (09-30-2015)
Upstream view of Stream 3 when
rechannelizes at UNT to Winters
Run (S8). View is west from flag S3-
6B.

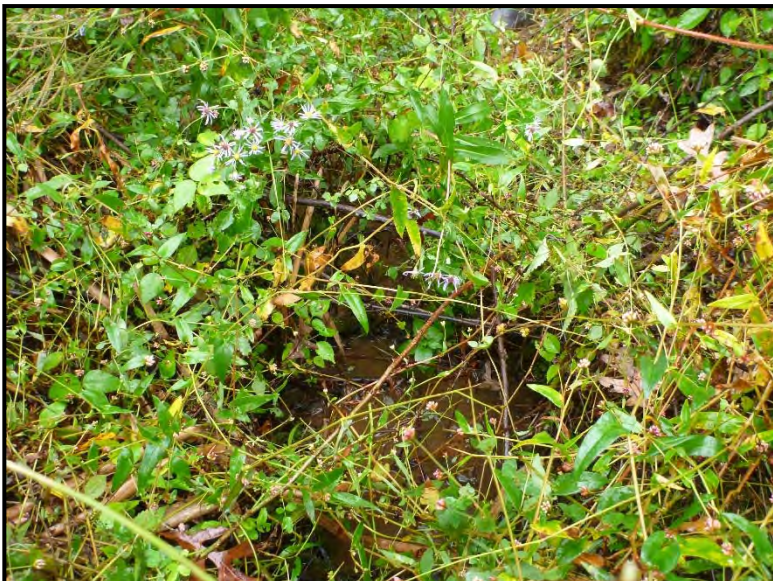
Photo 15 (09-30-2015)
Downstream view of Stream 4,
intermittent stream draining Wetland
2 into UNT to Winters Run (S8).
View is east from flag S4-1.

Photo 15 (09-30-2015)
Downstream view of Stream 4,
intermittent stream draining Wetland
2 into UNT to Winters Run (S8).
View is east from flag S4-1.

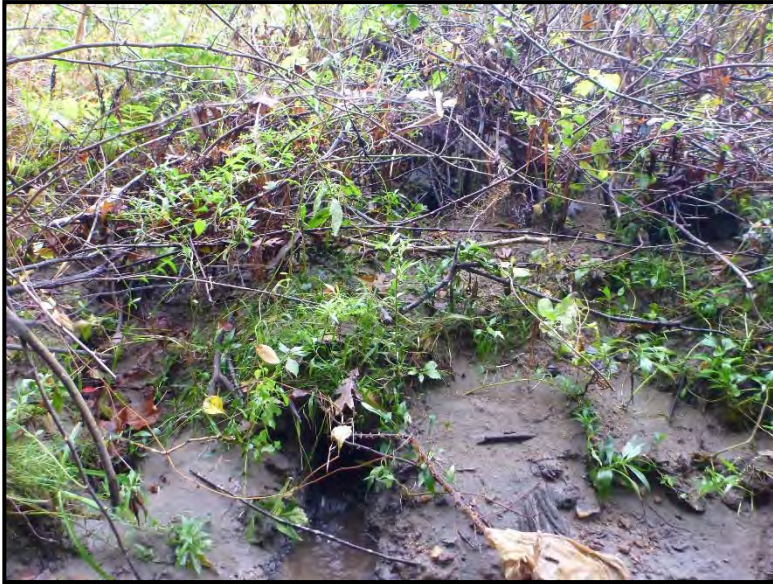
Photo 16 (09-30-2015)
Upstream view of Stream 4 at junction with UNT to Winters Run (S8). View is northwest from flag S4-2.

Photo 16 (09-30-2015)
Upstream view of Stream 4 at junction with UNT to Winters Run (S8). View is northwest from flag S4-2.

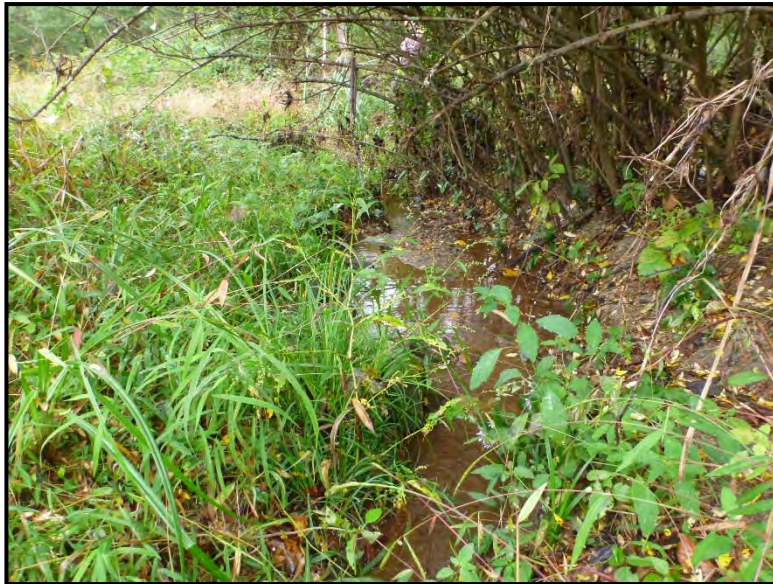
Photo 17 (09-30-2015)
Downstream view of Stream 5, intermittent stream draining Wetland 2 into UNT to Winters Run (S8). View is east from flag S5-2.

Photo 17 (09-30-2015)
Downstream view of Stream 5, intermittent stream draining Wetland 2 into UNT to Winters Run (S8). View is east from flag S5-2.

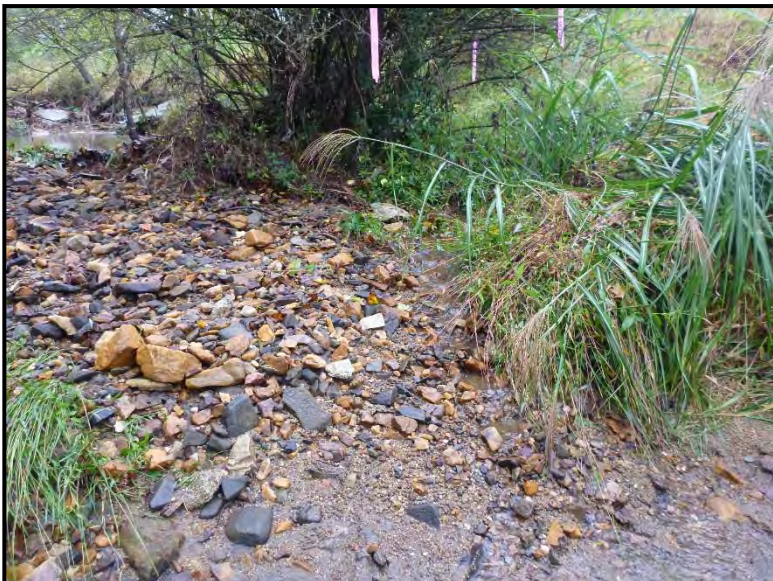
Photo 18 (09-30-2015)
Upstream view of Stream 5 at junction with UNT to Winters Run (S8). View is west from flag S5-3.

Photo 18 (09-30-2015)
Upstream view of Stream 5 at junction with UNT to Winters Run (S8). View is west from flag S5-3.

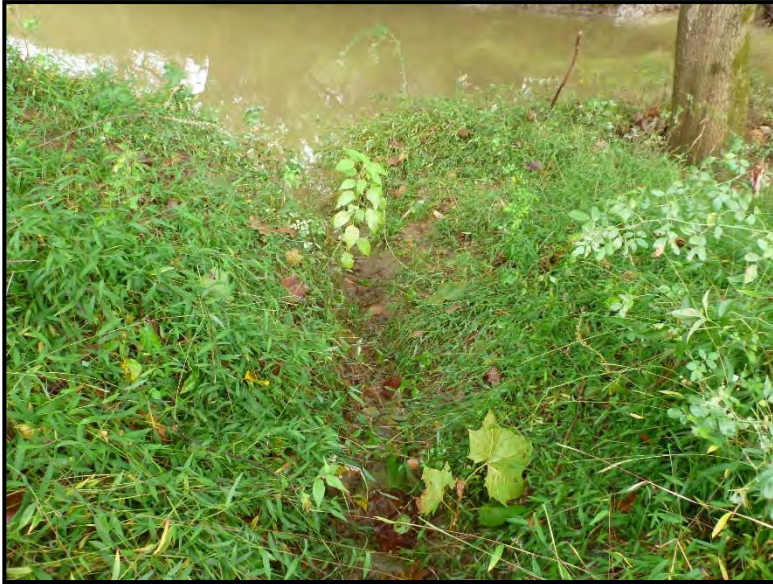
Photo 19 (09-30-2015)
Downstream view of Stream 6, ephemeral drainage of overland flow from agricultural field into UNT to Winters Run (S8). View is southeast from flag S6-1.

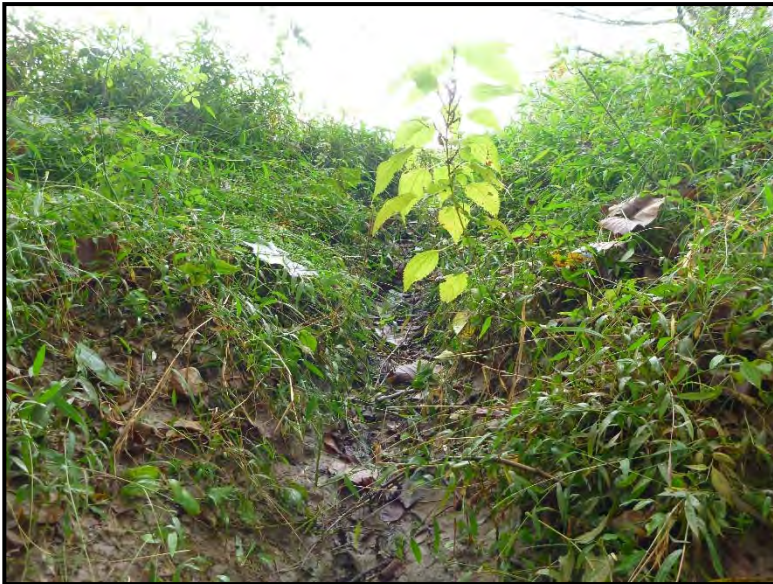
Photo 20 (09-30-2015)
Upstream view of Stream 6 from junction with UNT to Winters Run (S8). View is northwest from flag S6-2.

Photo 20 (09-30-2015)
Upstream view of Stream 6 from junction with UNT to Winters Run (S8). View is northwest from flag S6-2.

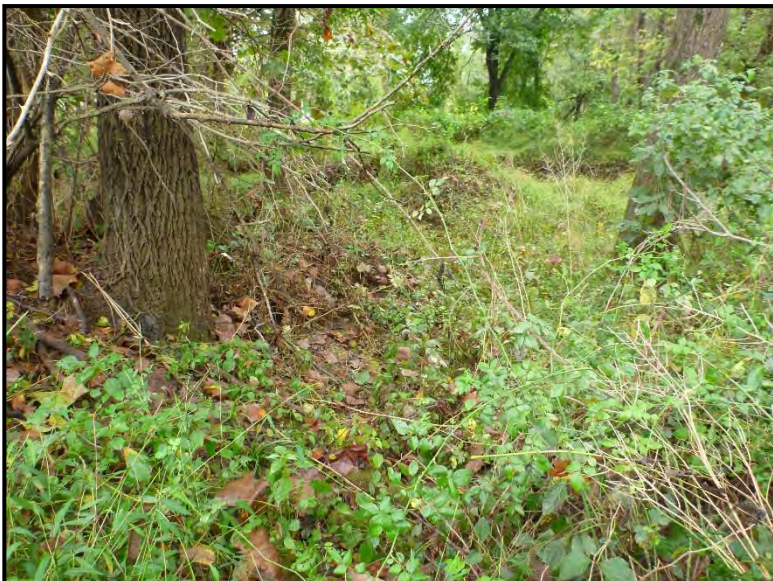
Photo 21 (09-30-2015)
Downstream view of Stream 7, ephemeral drainage of overland flow from agricultural field into UNT to Winters Run (S8). View is southeast from flag S7-1.

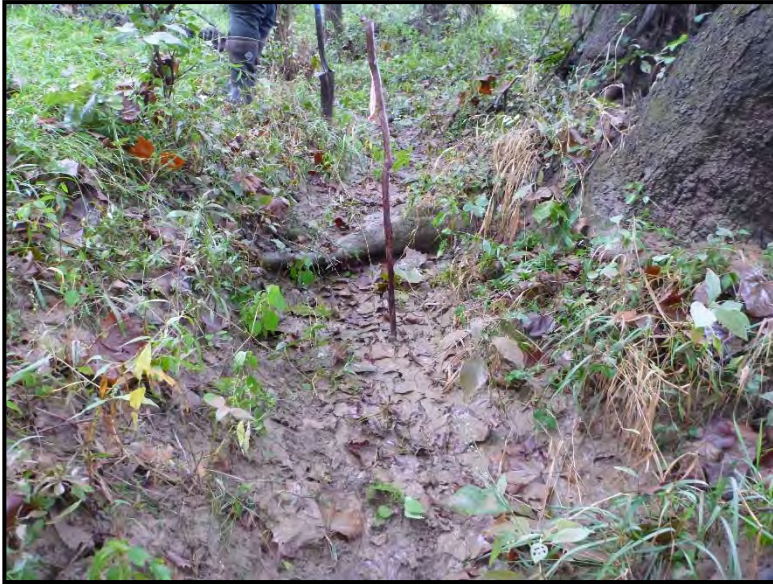
Photo 22 (09-30-2015)
Upstream view of Stream 7 from junction with UNT to Winters Run (S8). View is north from flag S7-3.

Photo 22 (09-30-2015)
Upstream view of Stream 7 from junction with UNT to Winters Run (S8). View is north from flag S7-3.

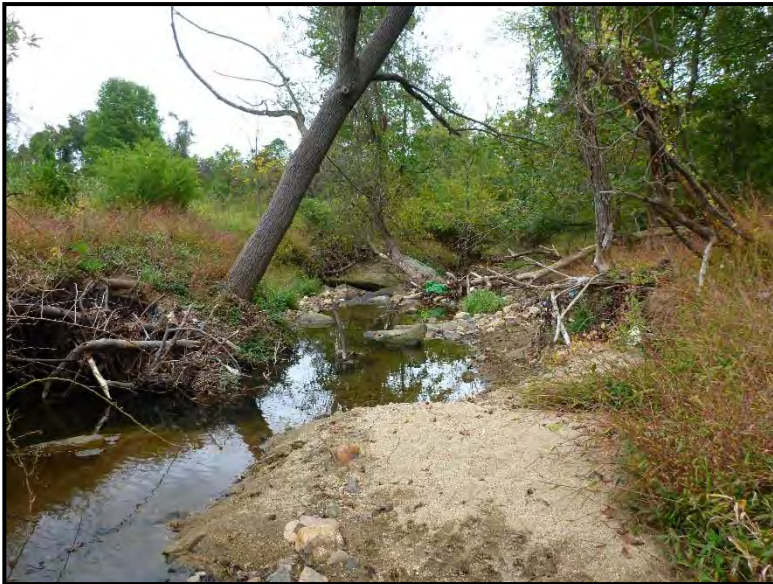
Photo 23 (09-29-2015)
Downstream view of Stream 8, UNT to Winters Run (S8). View is north near flag W2-11.

Photo 23 (09-29-2015)
Downstream view of Stream 8, UNT to Winters Run (S8). View is north near flag W2-11.

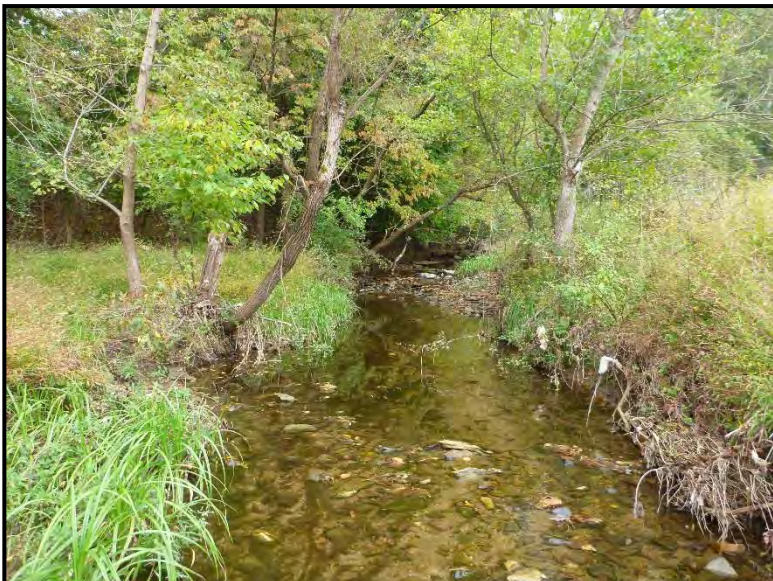
Photo 24 (09-29-2015)
Upstream view of Stream 8, UNT to Winters Run (S8). View is southwest near flag W2-11.

Photo 24 (09-29-2015)
Upstream view of Stream 8, UNT to Winters Run (S8). View is southwest near flag W2-11.

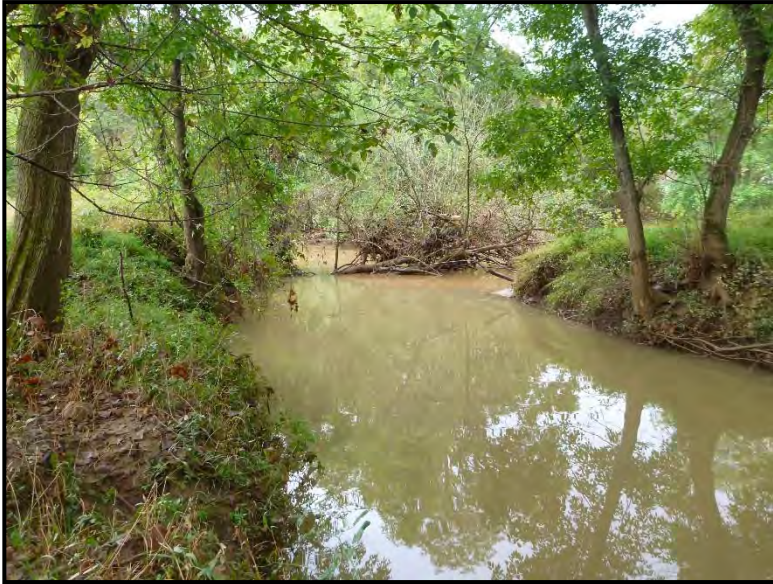
Photo 25 (09-30-2015)
Downstream view of Stream 8, UNT to Winters Run (S8) at junction with Winters Run after heavy rains previous evening. View is southeast near flag S7-3.

Photo 25 (09-30-2015)
Downstream view of Stream 8, UNT to Winters Run (S8) at junction with Winters Run after heavy rains previous evening. View is southeast near flag S7-3.
