**JOINT FEDERAL/STATE APPLICATION
FOR THE ALTERATION OF ANY
FLOODPLAIN, WATERWAY, TIDAL OR
NONTIDAL WETLAND IN MARYLAND**

APPLICATION AMENDMENT 1

**BEL AIR IMPOUNDMENT AND
WINTERS RUN INTAKE PROJECT**

Town of Bel Air
Harford County, Maryland

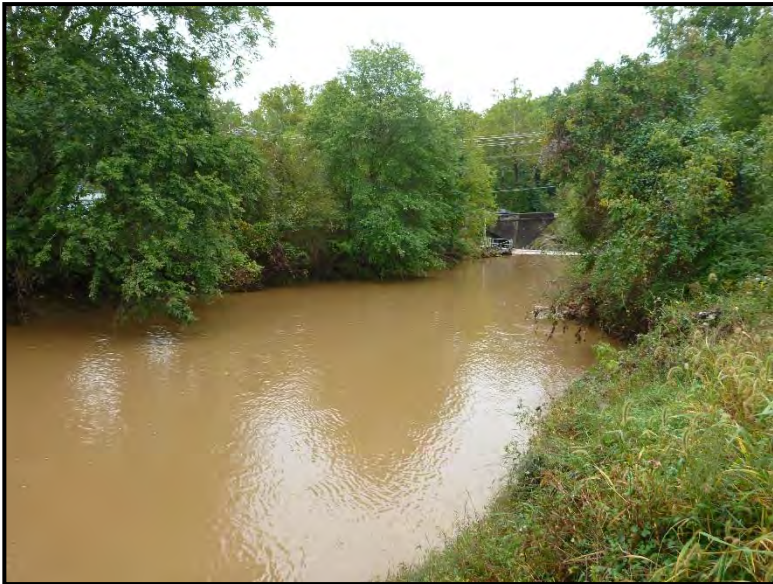
Photo 26 (09-30-2015)
Downstream view of Winters Run (WR) at junction with UNT to Winters Run (S8) after heavy rains previous evening. View is southeast.

Photo 26 (09-30-2015)
Downstream view of Winters Run (WR) at junction with UNT to Winters Run (S8) after heavy rains previous evening. View is southeast.

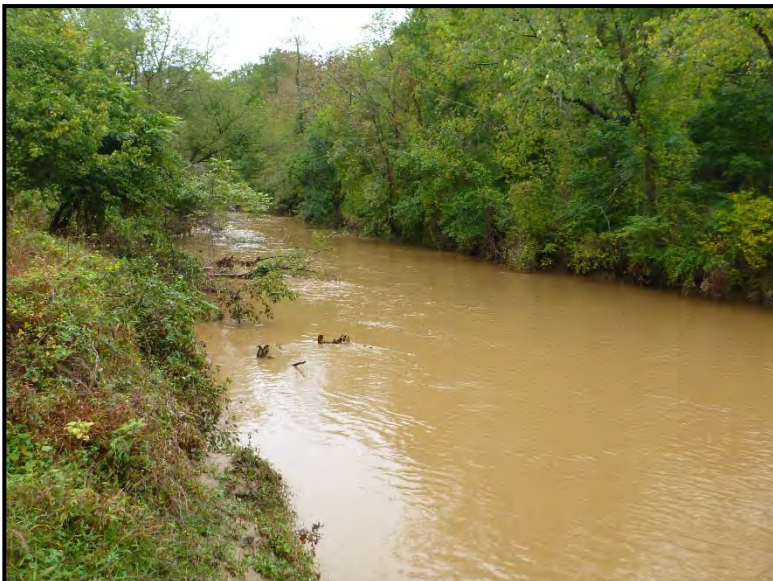
Photo 27 (09-30-2015)
Upstream view of Winters Run (WR) at junction with UNT to Winters Run (S8) after heavy rains previous evening. View is north.

Photo 27 (09-30-2015)
Upstream view of Winters Run (WR) at junction with UNT to Winters Run (S8) after heavy rains previous evening. View is north.

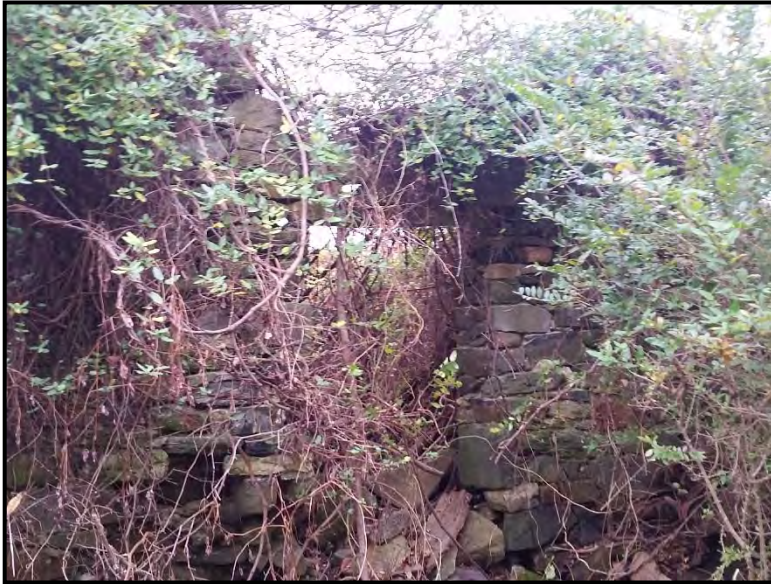
Photo 28 (11-02-2015)
View of springhouse source of Stream 3. View is northwest.

Photo 28 (11-02-2015)
View of springhouse source of Stream 3. View is northwest.

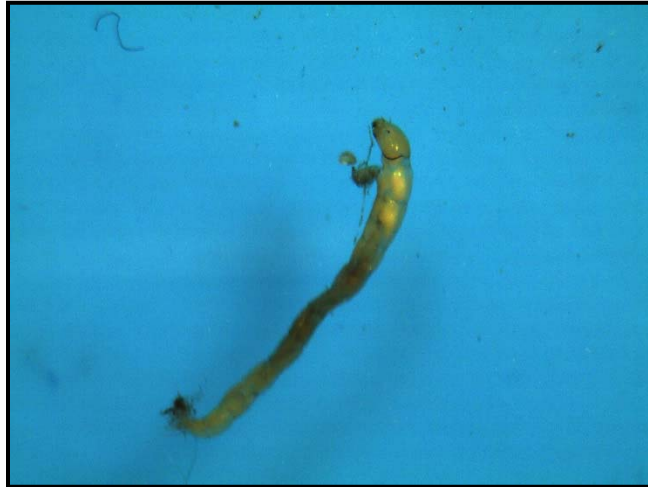
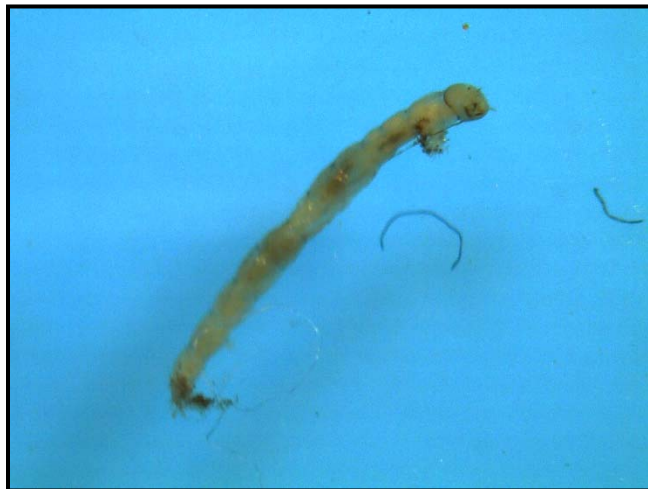
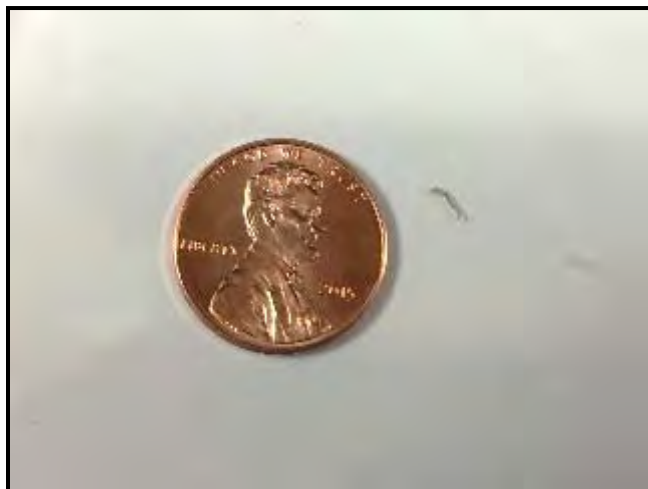
Identification Summary	
Order	Diptera
Family	Chironomidae
Genus	Family
Common Name	Non-Biting Midges
Life Stage	Larvae
Hilsenhof Tolerance Value	6
Functional Feeding Group	Collector-Gatherer

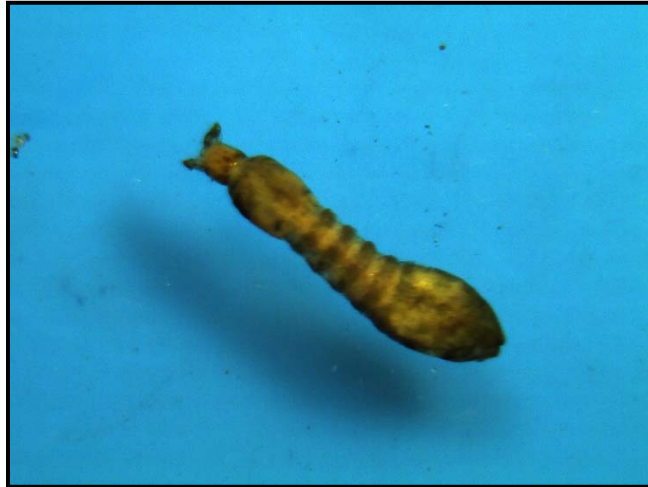
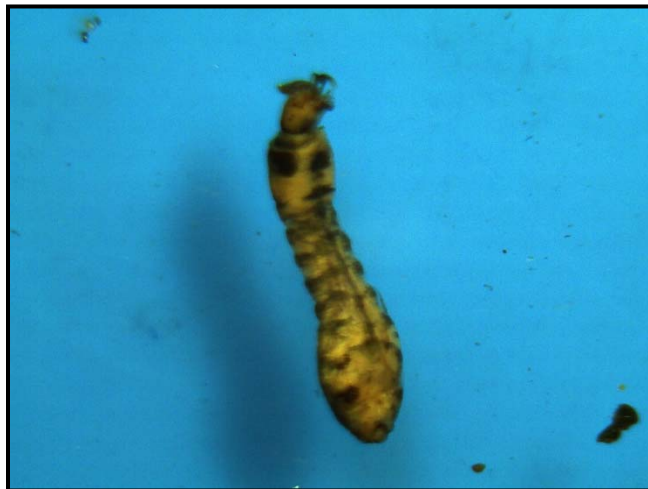
Identification Summary	
Order	Diptera
Family	Simuliidae
Genus	Family
Common Name	Black Flies, Buffalo Gnats
Life Stage	Larvae
Hilsenhof Tolerance Value	6
Functional Feeding Group	Filter-Collector

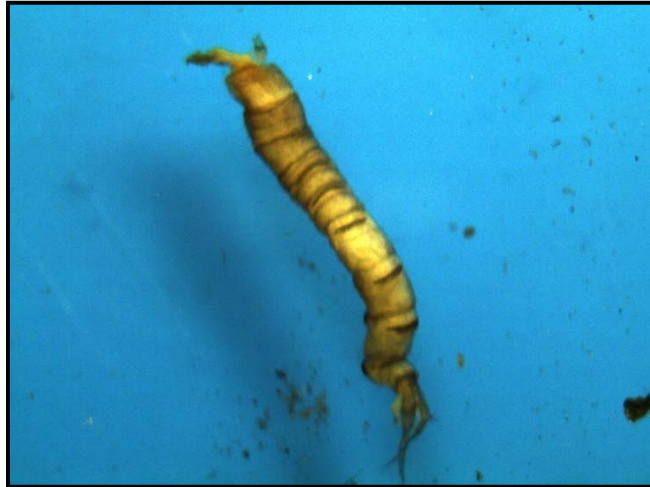
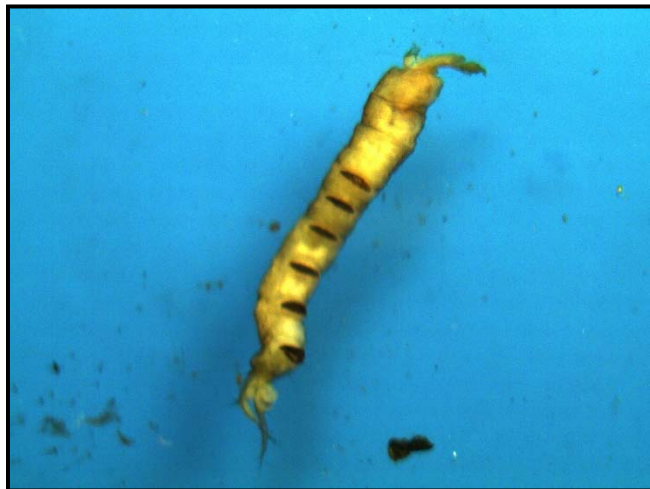
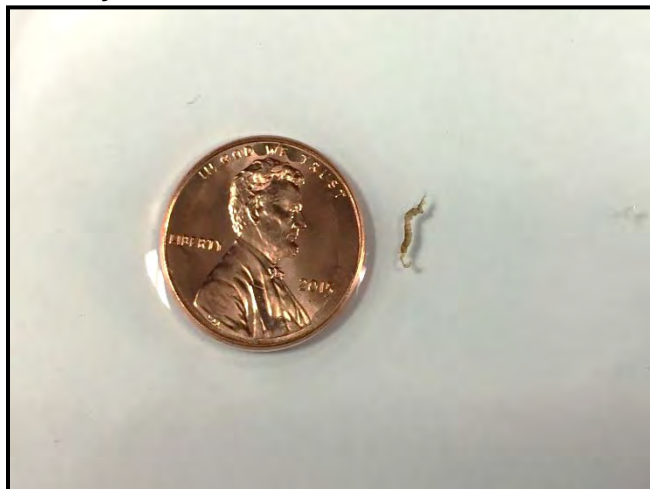
Identification Summary	
Order	Diptera
Family	Tipulidae
Genus	<i>Antocha</i>
Common Name	Crane Flies
Life Stage	Larvae
Hilsenhof Tolerance Value	3
Functional Feeding Group	Collector-Gatherer

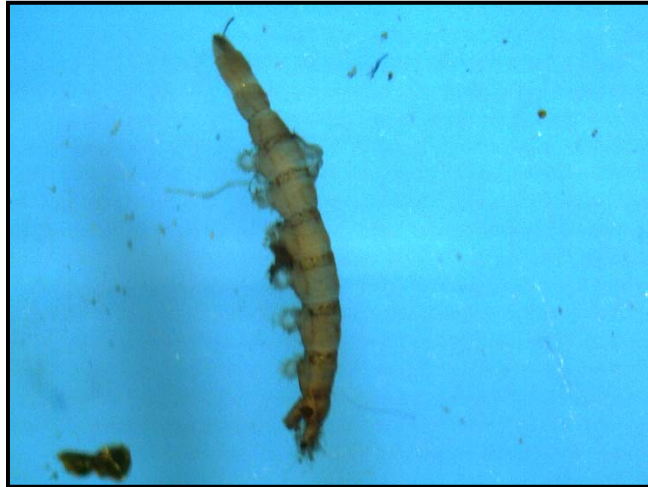
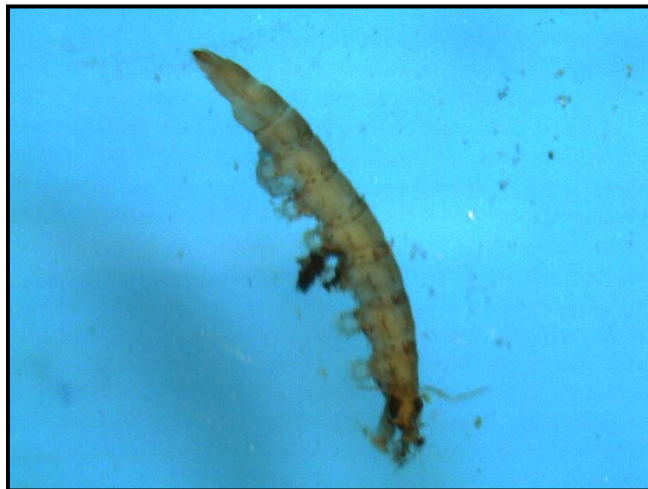
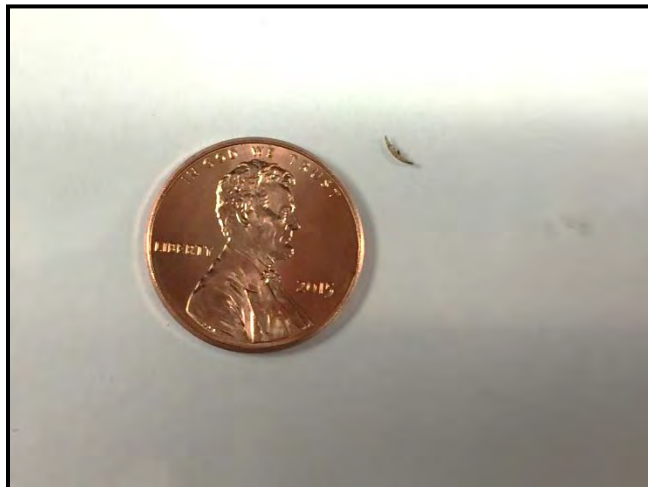
Identification Summary	
Order	Diptera
Family	Empididae
Genus	<i>Hermerodromia</i>
Common Name	Dance Flies
Life Stage	Larvae
Hilsenhof Tolerance Value	6
Functional Feeding Group	Predator

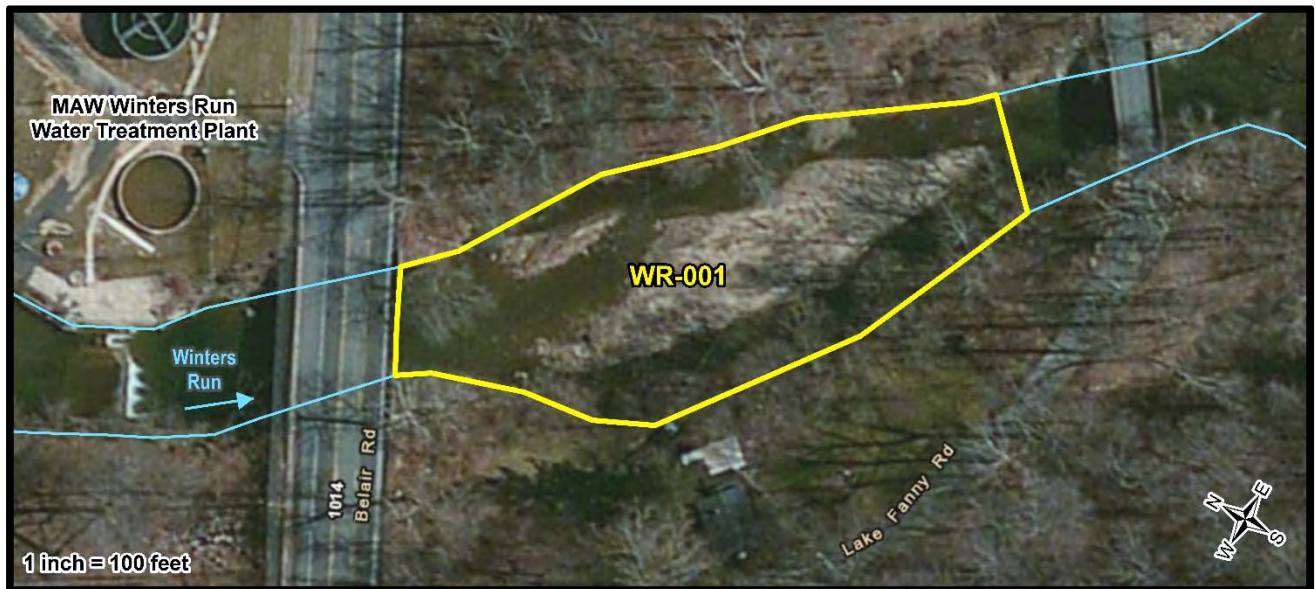
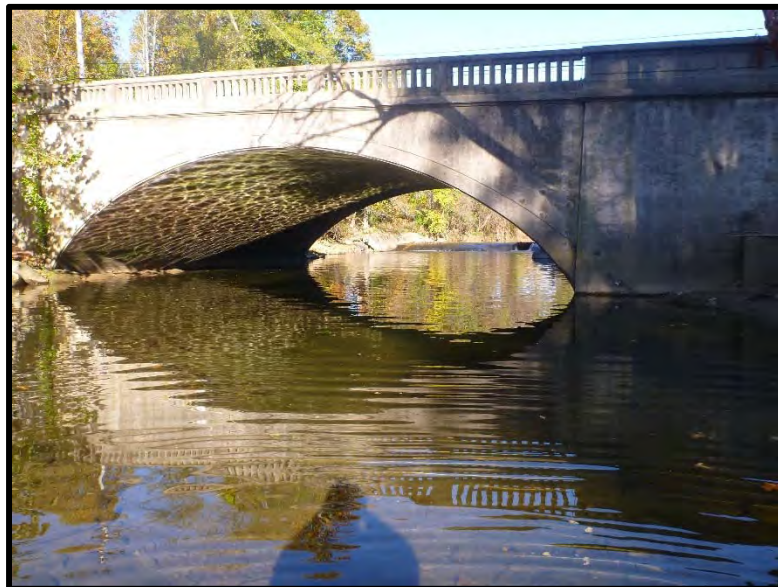
Photo 1 (10-19-2015)

View upstream from Sampling Reach WR-001. The bridge carrying Bel Air Rd over Winters Run is shown, as well as the water treatment plant dam upstream of the bridge.

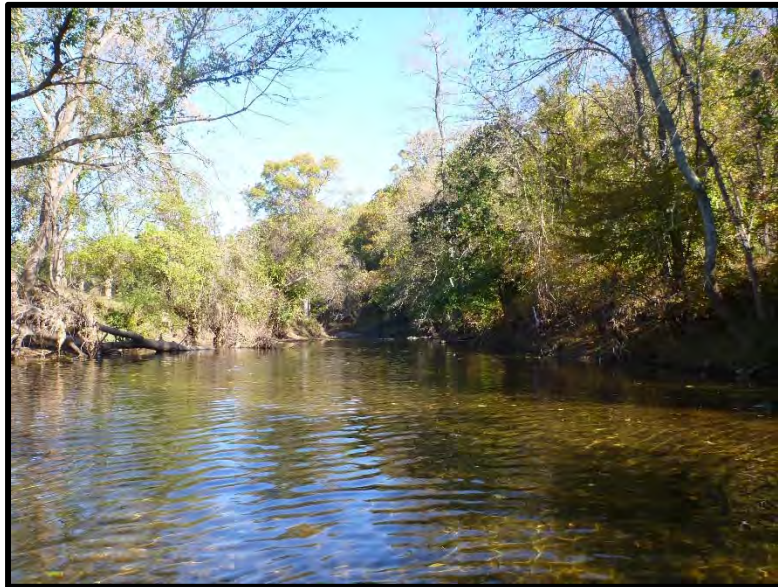
Photo 3 (10-19-2015)
View of Sampling Reach WR-002
looking upstream.

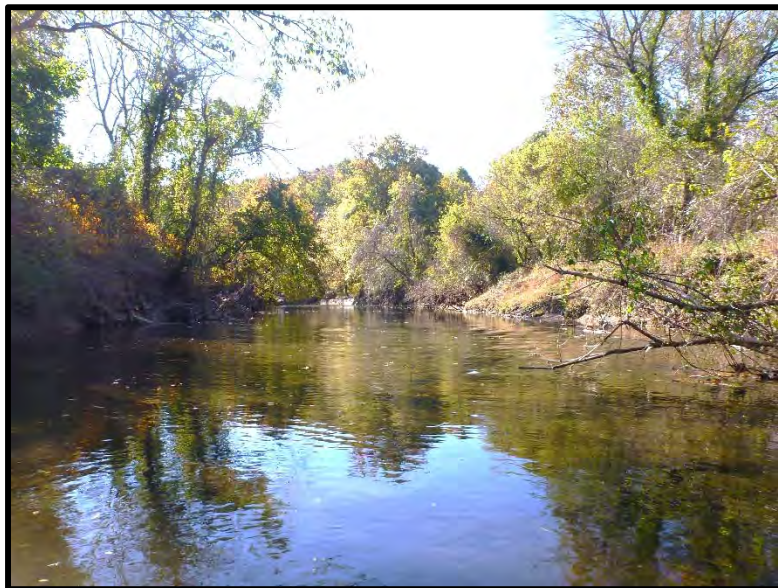
Photo 4 (10-19-2015)
View of Sampling Reach WR-002
looking downstream.

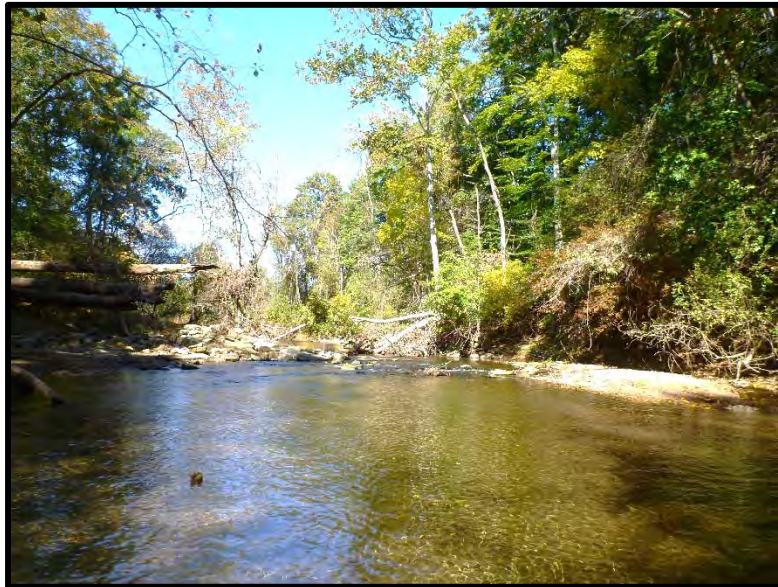
Photo 5 (10-19-2015)
View of Sampling Reach WR-003
looking upstream.

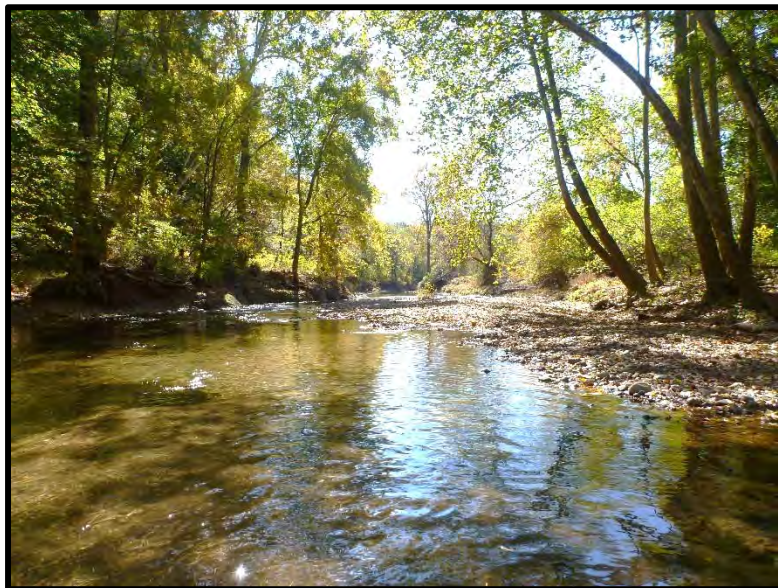
Photo 6 (10-19-2015)
View of Sampling Reach WR-003
looking downstream.

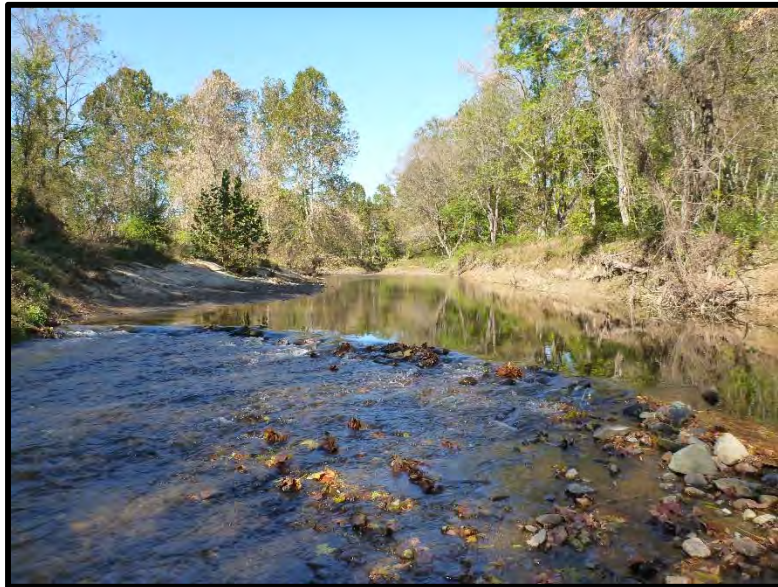
Photo 7 (10-19-2015)
View of Sampling Reach WR-005 looking upstream.

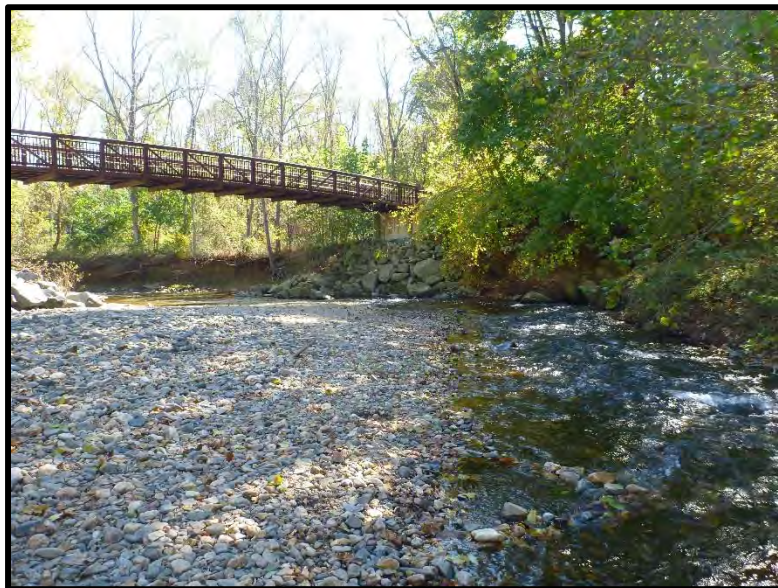
Photo 8 (10-19-2015)
View of Sampling Reach WR-005 looking downstream. The park's pedestrian bridge over Winters Run is shown.

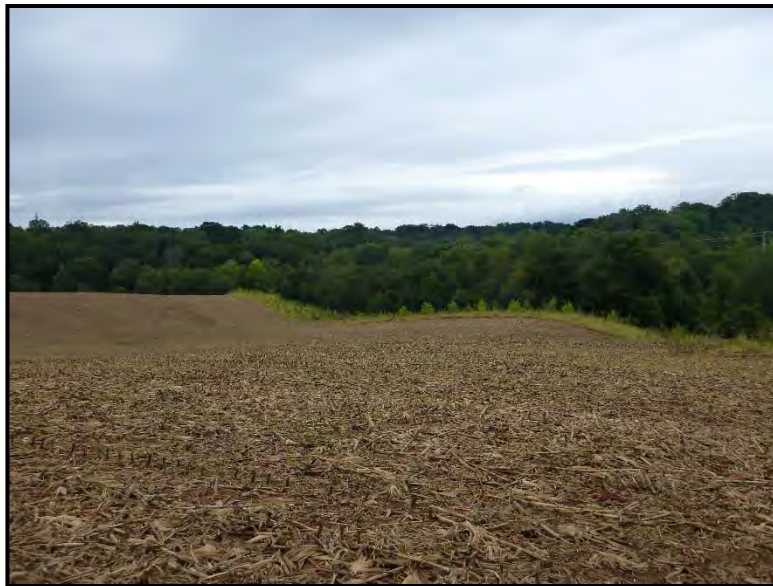
Photo 2 (09-29-2015)
View of the agricultural field and reforestation planting area looking east.

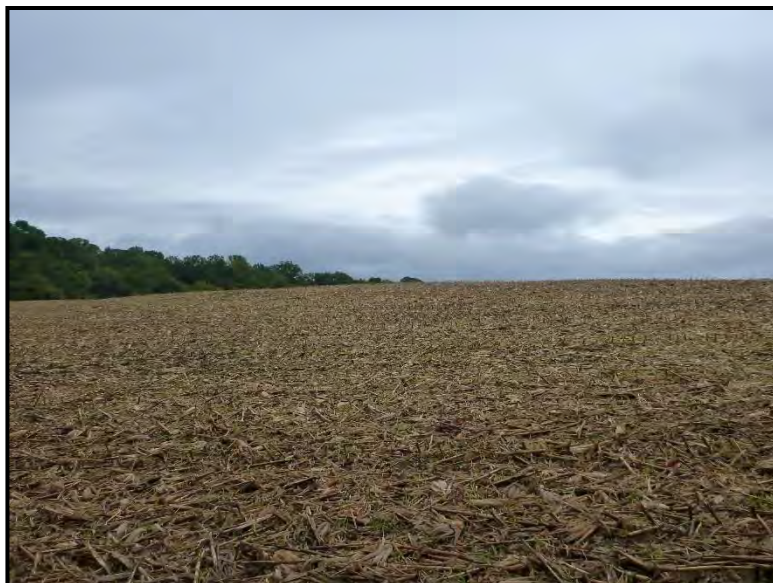
Photo 3 (09-29-2015)
View of the agricultural field and approximate reservoir location looking south from floodplain forest tree line.

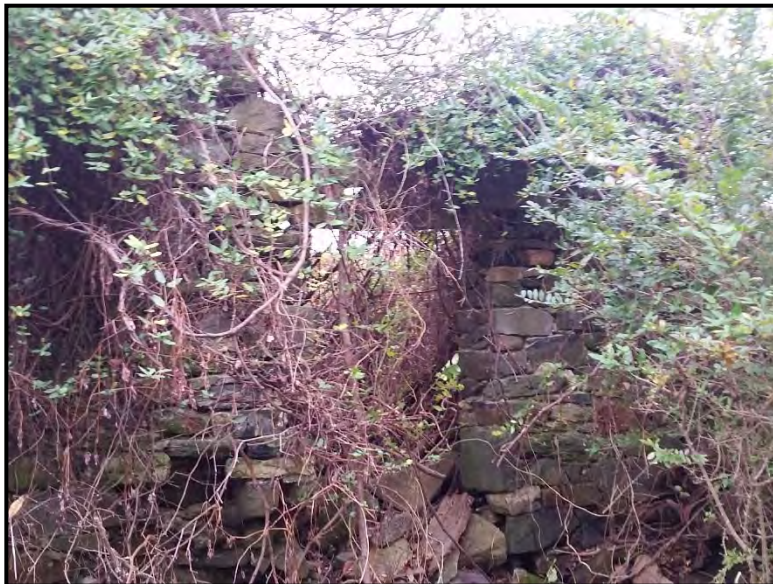
Photo 8 (11-02-2015)
View of springhouse located downslope of the reforestation planting area and the wetland complex.

Photo 8 (11-02-2015)
View of springhouse located downslope of the reforestation planting area and the wetland complex.

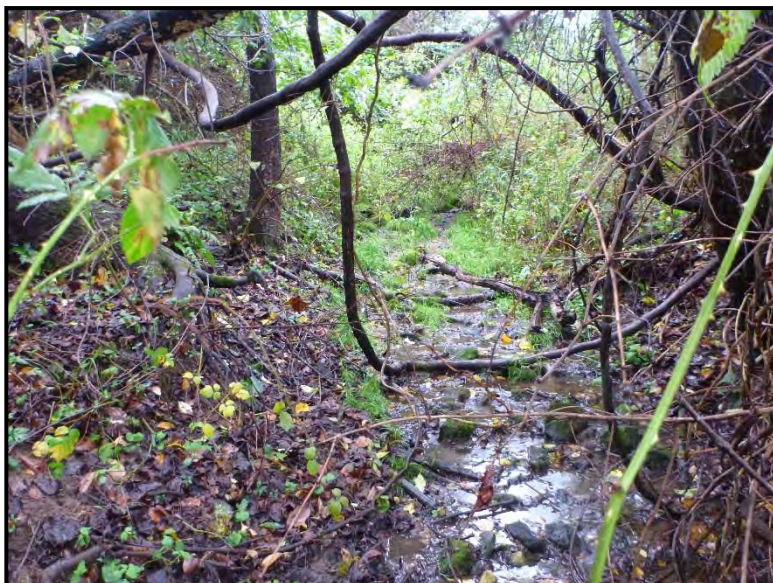
Photo 9 (09-30-2015)
Downstream view from the spring house. The watercourse drains into a palustrine emergent (PEM) wetland complex, then to an unnamed tributary to Winters Run. View is east.

Photo 9 (09-30-2015)
Downstream view from the spring house. The watercourse drains into a palustrine emergent (PEM) wetland complex, then to an unnamed tributary to Winters Run. View is east.
