Backflow Incidents That Could Have Been Prevented

LEARN FROM 15 REAL-LIFE BACKFLOW CASE STUDIES

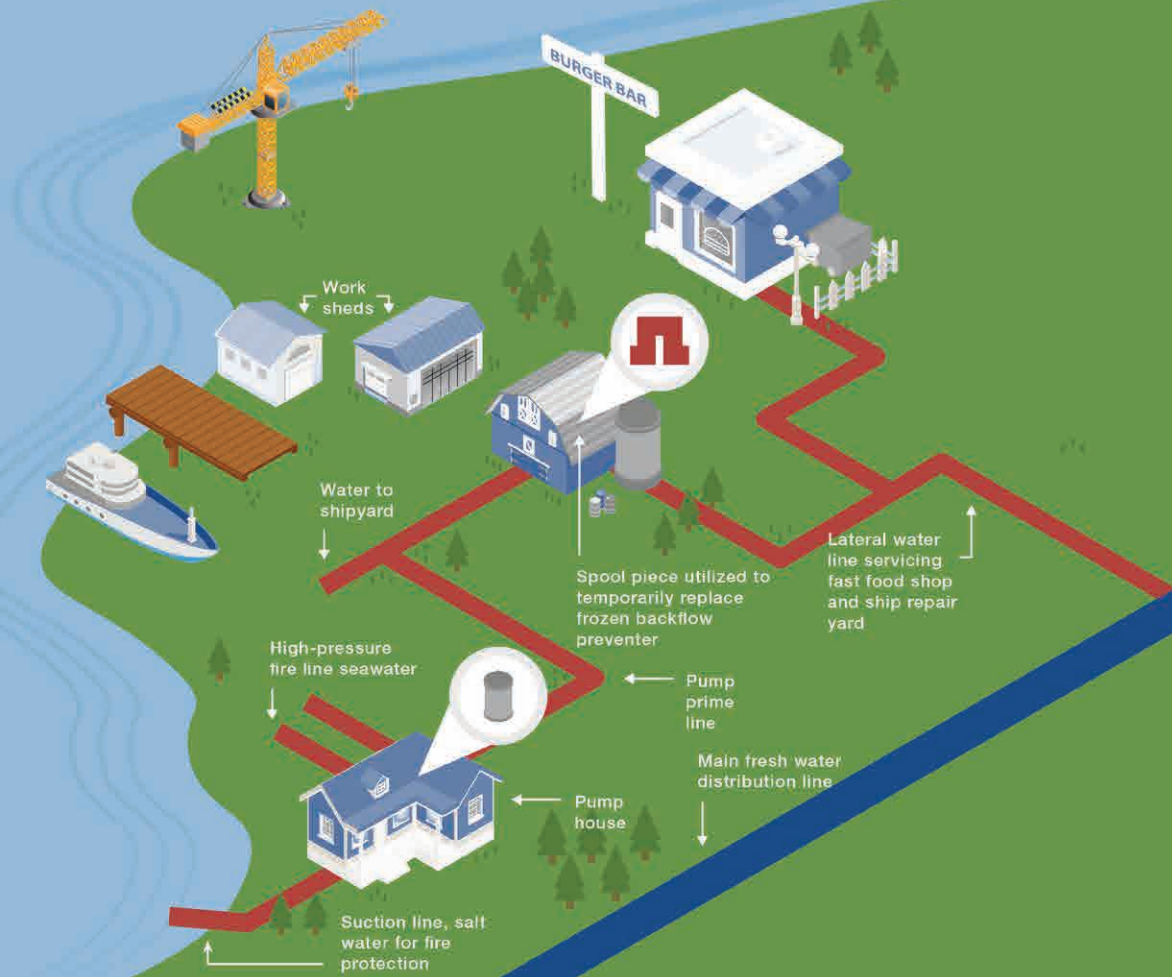
A check with adjacent water customers revealed another complaint of salty water from a nearby waterfront ship-repair facility. Both the restaurant and the shipyard were served from the same water-main lateral, which stemmed from the main distribution line. Officials promptly conducted a cross-connection control inspection of the ship-repair facility and revealed the following details:

- The backflow preventer installed on the service line to the shipyard had frozen and burst earlier in the winter. It had been removed and replaced by a sleeve in order to maintain the water supply to the shipyard, thereby eliminating all protection against backflow.
- The shipyard fire protection system consisted of high-pressure seawater maintained by both electric and diesel-driven pumps.
- The pumps were primed through the use of a city water line, which was directly connected to the high-

pressure fire system. With the priming line left open and the first service pumps maintaining high pressure in the fire-service lines, raw salt water was being pumped under positive backpressure through the sleeve into the public water-distribution system.

To correct the problem, the city-water prime line to the pumps was removed and a new backflow preventer was promptly installed at the service line in place of the sleeve. To prevent future freeze-ups, heat tape was wrapped around the backflow preventer.

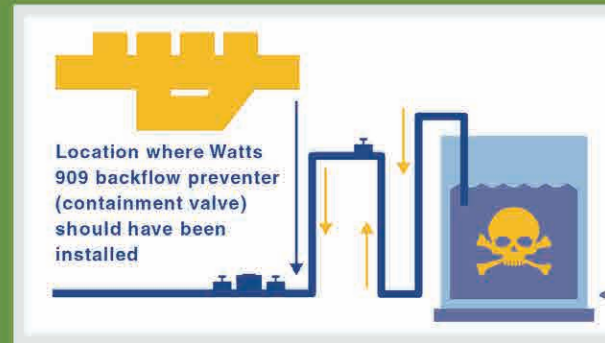
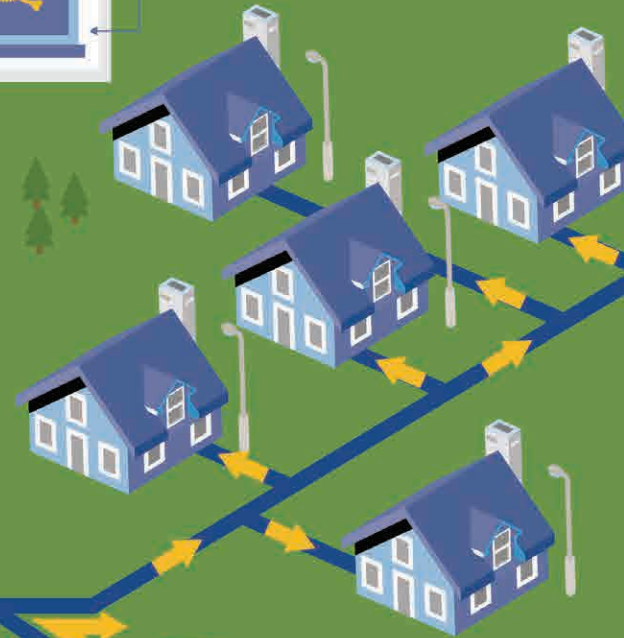
Pesticide mix: Dursban, chlordane, heptachlor, and lindane

- Flow of pesticide during backsiphonage
- ← Flow of pesticide following repair of water main

Water main break & repair

A pesticide used for termite control was found in the water supply of a northern New Jersey municipality, leaving 63 homes without water. A construction crew inadvertently broke a water main while widening a bridge, and in the two hours it took to repair the break, pest-control chemicals back-siphoned from a pesticide company into the water main. Several hours after workers repaired the water main break, a customer called the Water Department to complain that the water was milky and smelled bad.

Officials arranged for a tank truck with potable water to be parked in the affected block, and made available shower facilities at the local public schools. Officials then flushed and super-chlorinated the affected water pipes.

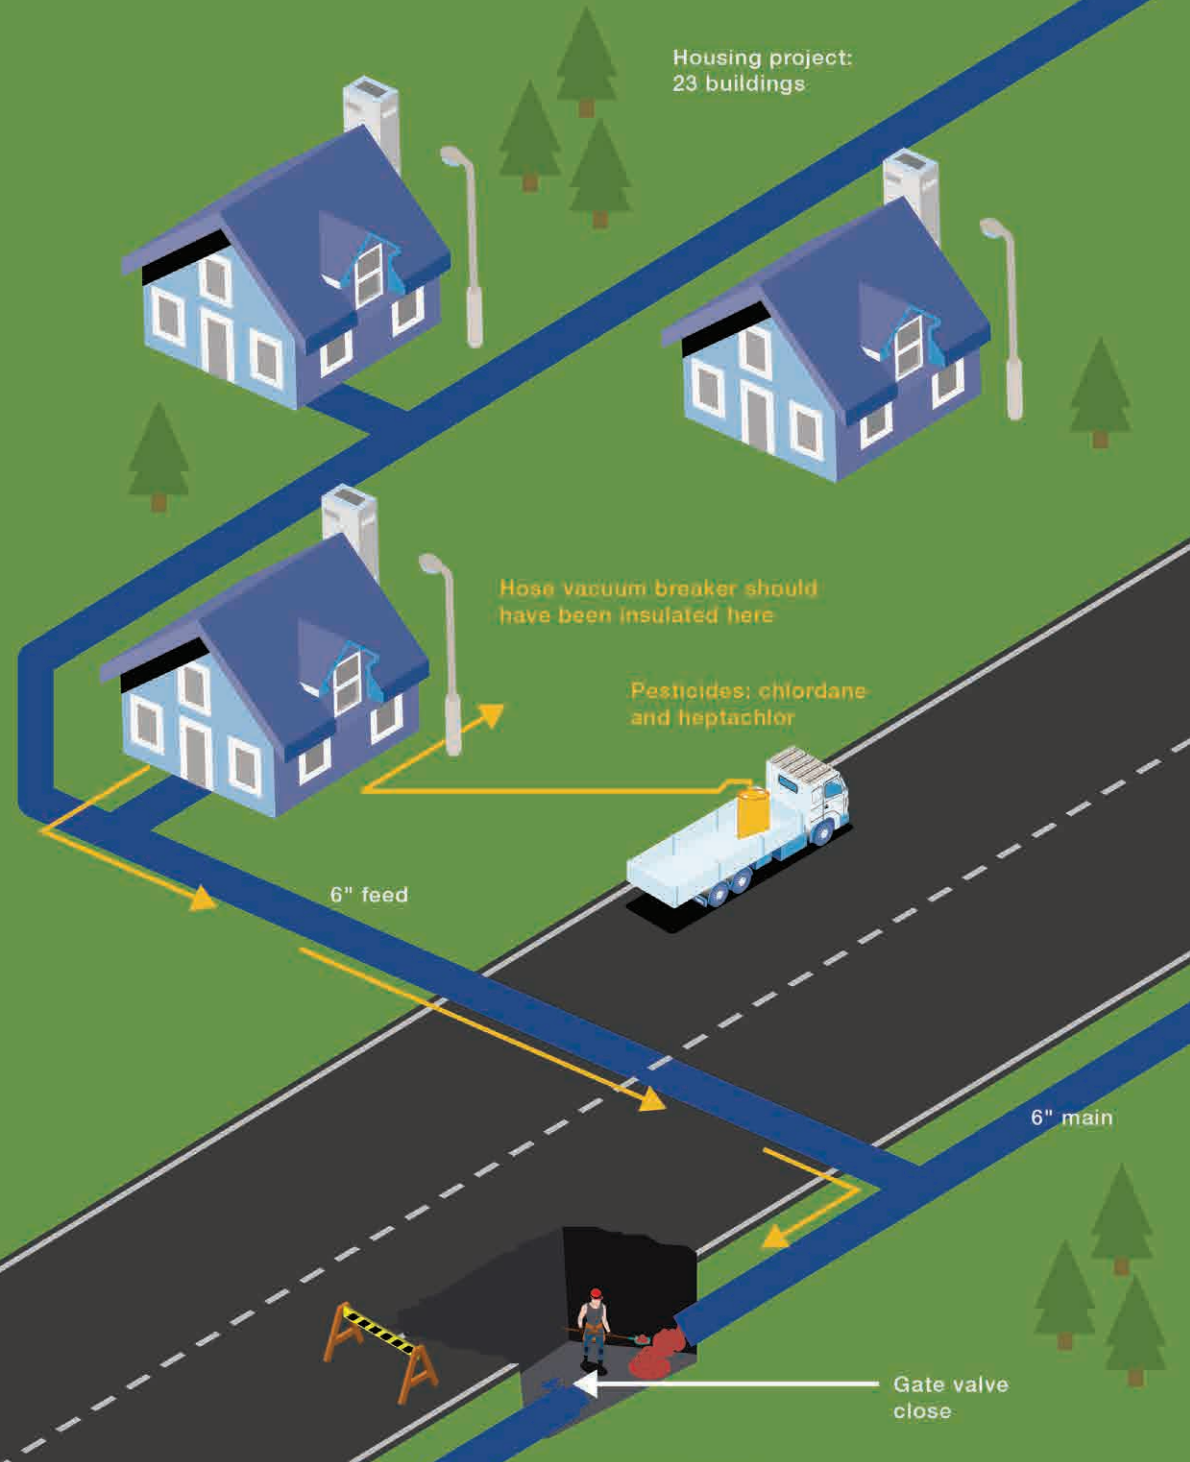
The insecticide contaminated the water supply system when an extermination company applied it as a preventative measure against termites. A pesticide contractor used water from a garden hose to mix chlordane and heptachlor in a tank truck; the end of the hose was submerged in the chemicals while the water lines to the area were being drained. A backsiphonage condition arose when a plumber cut into a main line to put in a gate valve and the water started to drain, because the drainage point was downstream of the tank truck. Consequently, an indeterminate amount of chemicals were siphoned out of the truck and fed into the system.

The insecticide contaminated the water service to 75 apartments, which housed about 300 people. After repeated efforts to clean and flush the lines, the Housing Authority ultimately decided to replace the water line and all affected plumbing.

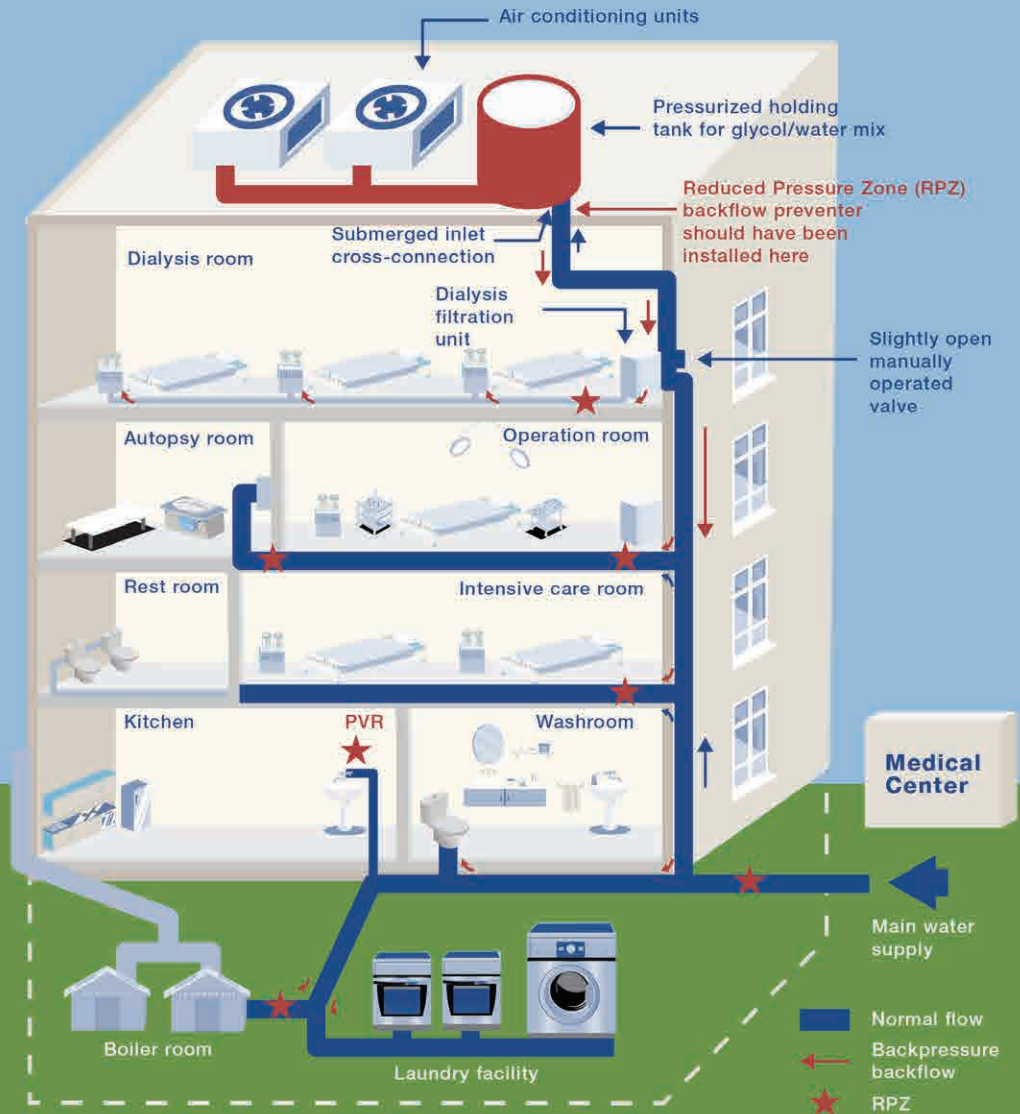
Ethylene glycol entered the dialysis equipment through a series of events triggered by a valve being left slightly open. The open valve permitted water to flow into a holding tank used to replenish a mix of glycol and water to the air conditioning system. Glycol is customarily used in air conditioning water to keep it from freezing in cold weather. With the valve partially open, water continually flowed slowly into the holding tank until the pressure

in the closed tank equaled the pressure in the water supply system—a dangerous situation.

As long as the supply pressure did not decrease in the line with the valve partially open, no backpressure flow would occur. However, if the supply pressure dropped for any reason, the hospital's potable supply lines would be contaminated with the glycol-water mix (as a result of the cross-connection at the holding tank combined with backpressure backflow).

Investigators theorized that someone in the medical center flushed a toilet or turned on a faucet, which dropped the pressure in the water pipes and allowed the glycol-water mixture to drain out of the holding tank and into the medical center's water pipes. Consequently, the contaminated water entered the dialysis filtration system used to purify water for the dialysis machines. This filtration system takes out trace chemicals, such as those used at the city water treatment plant; however, the system could not handle the sudden heavy load of chemicals.

If the water supply to the glycol tank had been air-gapped or protected with a reduced pressure principle backflow preventer, the dialysis machines would not have been contaminated. This incident highlights the need for hydraulic containment of hazardous areas in hospitals and medical centers. Mortuary rooms, autopsy rooms, laundry rooms, boiler rooms, air conditioning units, and pharmacy rooms should all be isolated and contained with the use of backflow preventers on their potable supply lines.

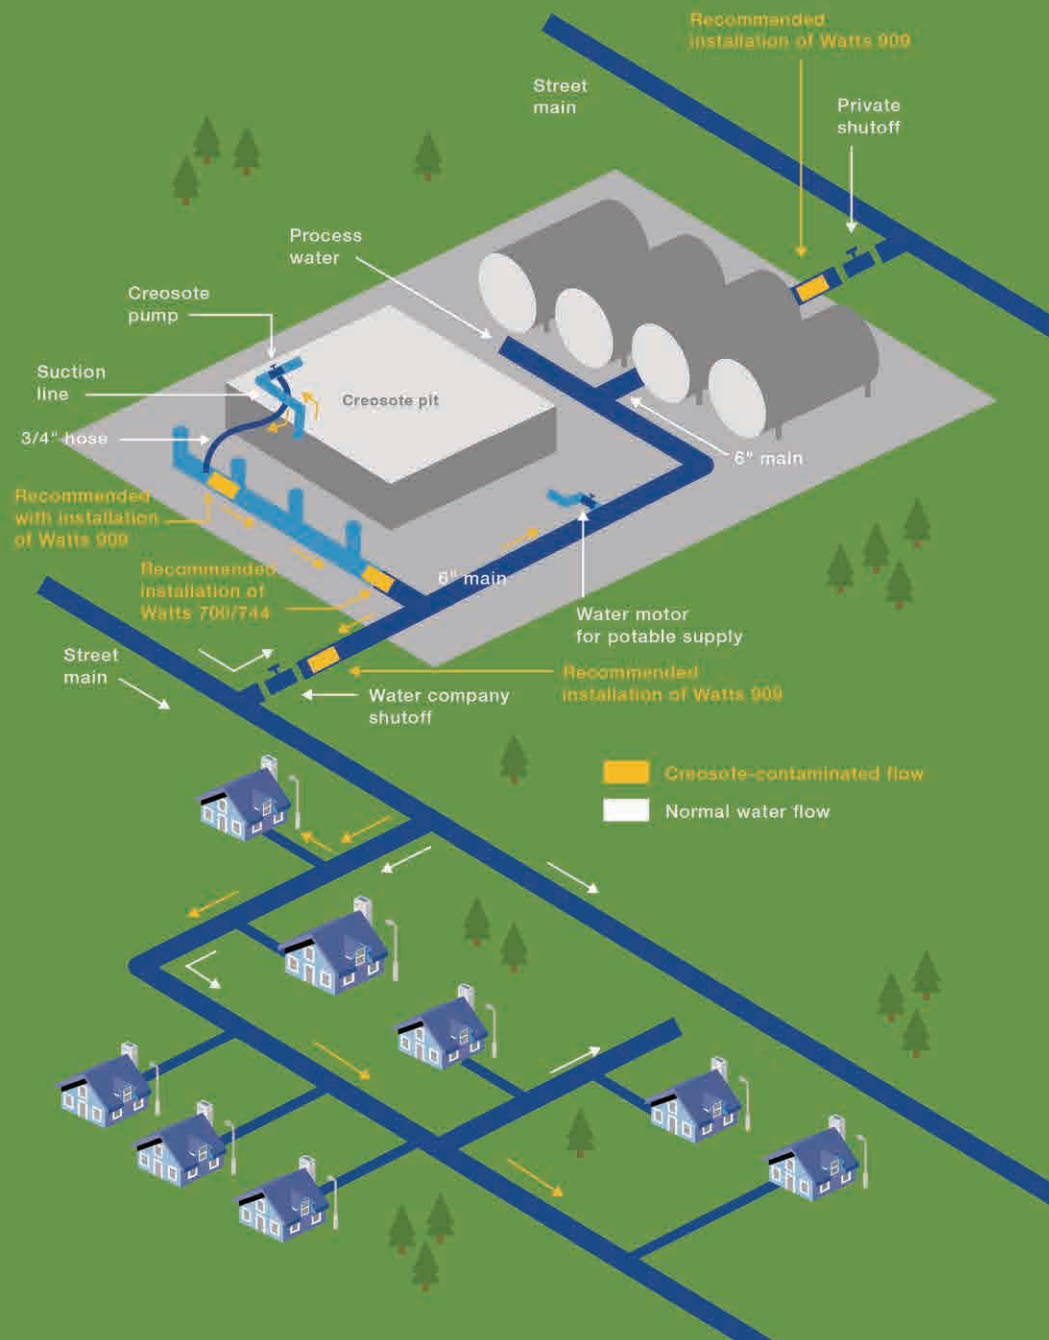
While a private fire hydrant was being repaired, a ¾-inch hose was used as a priming line between a fire service connection and the suction side of a creosote pump—and creosote back-siphoned into and contaminated a section of the water distribution system.

Investigation into the cause of the incident showed that the wood preservative company, as part of its process, pumped creosote from collective pits to other parts of its operation. The pump automatically shut off when the creosote in the pit dropped to a predetermined level, and then restarted after the creosote returned to a higher level. The pump, however, often lost its prime prior to the pit refilling. To prevent the loss of the prime, the wood preservative company connected the suction side of the pump to a hose from a ¾-inch hose bibb located on the fire service line. The hose bibb remained open continuously in an effort to keep the pump primed at all times.

It had been necessary to remove the damaged hydrant to make repairs, and since the line was at a significantly lower level than the pit, the creosote then back-siphoned through the priming line connecting the creosote pit to the fire service line. After the hydrant was repaired and the water service was restored, the creosote in the fire lines had been flushed out into the main water distribution system.

After flushing the wood preservative company's system for 24 hours, it was discovered that creosote had reached, and remained in, the far areas of the fire system. Backflow preventers were installed and all lines on the property completely flushed prior to restoring service.

If backflow prevention devices had been installed, the situation could have been averted. For example, reduced pressure zone backflow preventers could have contained the creosote contamination. The risk of the cross-connection would have been reduced by adding a ¾-inch reduced pressure zone backflow preventer to the priming line. And since the wood preservative company used a metered domestic water line that branched off the fire line service, a reduced pressure principle backflow preventer should have been installed at the meter to prevent contamination of the internal potable water supply.
